We will review the data (NTSB IAD05FA047, March 26, 2005) from the PC12 Bellefonte, PA accident. Starting from the New York Center handoff until the end of the flight we will examine the Instrument Procedures related factors (State College, PA ILS Rwy 24, see diagrams) and the PC12 performance/operations factors. Authors note: The following review is not meant to lay blame on any individual(s) or companies but is my interpretation of the factual data and is to be used for furthering the safety and operation of the PC12.

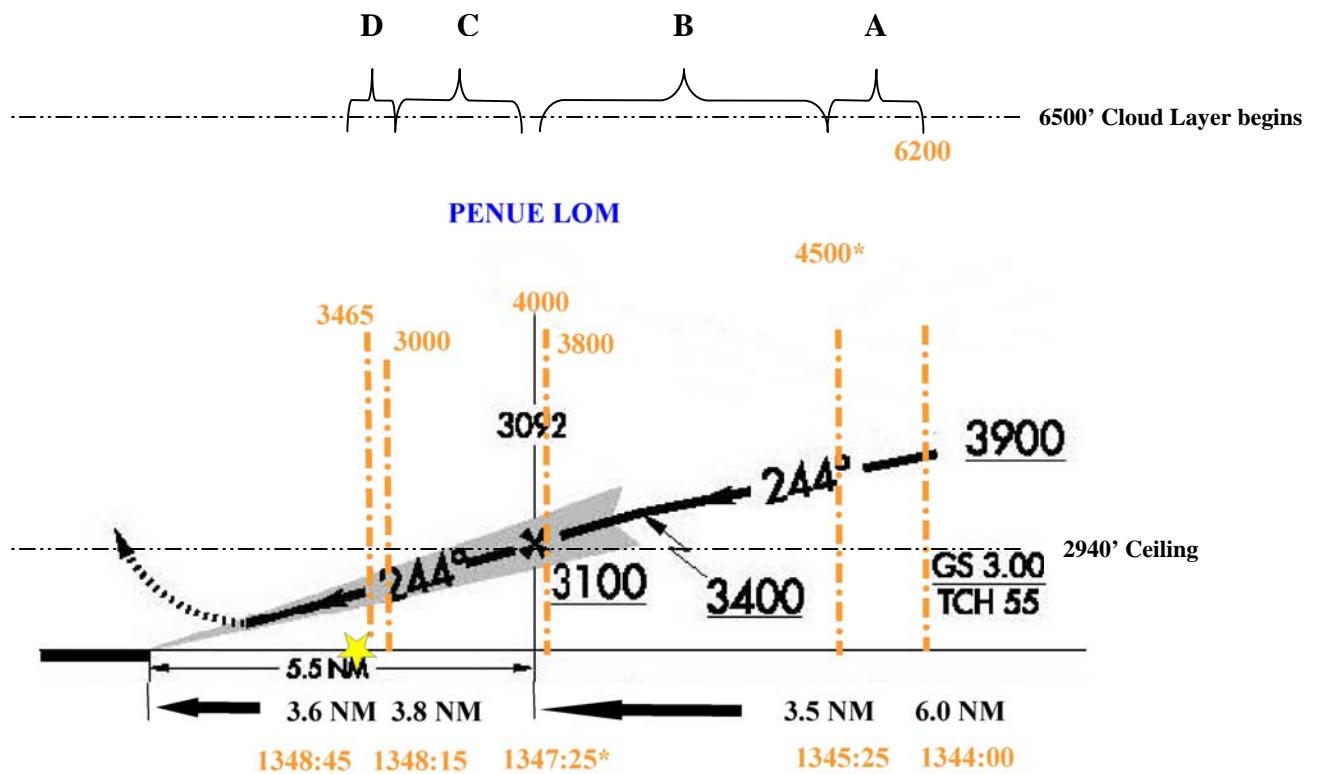
* Estimated-Data not given

- Based on the data the estimated ground speed would be 100 Knots, the descent rate was 1200 fpm and the 4500' estimate 1-½ dots above a 3° slope at that distance from the threshold.
- Based on the data the estimated ground speed would be 100 Knots, the descent rate was 350 fpm until reaching PENUE LOM (5.5 NM from the threshold) at between 3800' and 4000'.
- Based on the data the estimated ground speed would be 120 Knots, the descent rate is reported to be 2100 fpm until reaching 3000'.
- Based on the data the estimated ground speed would be (?) Knots, the climb rate is reported to be 2500 fpm until last radar contact at 3465'.

Section A: The ATC controller clears the PC12 for the ILS 24 approach. The aircraft is at 6200' and 6 miles from PENUE LOM. At 10 miles from the LOM the minimum segment altitude is 3900' so the PC12 is approximately 2000' above and is establishing an intercept to final.

Section B: At 3.5 NM from PENUE LOM, and approximately 4500', the pilot reduces the descent rate from 1200 fpm to 350 fpm until approximately reaching PENUE LOM, where the PC12 levels at 3800' and then climbs to 4000'.

Chain Link: At the beginning of this section it is possible that passing over the PENUE LOM the pilot may have lowered the landing gear upon receiving the Middle Marker beacon. The PC12 then began a 2100 fpm descent rate with a slightly better ground speed. Still not able to acquire the glide slope after 1.7 NM inside the LOM (and approximately: 50 seconds).

Section D: It is hard to say what was the ground speed or power at this point. Even the exact time from the decent rate to the ascent point is not precise but the radar return showed a climb rate of 2500 fpm even though the last return only has a altitude gain of 465' from its lowest point approximately: 30 seconds earlier.

Link break: The pilot could have requested a lower altitude sooner (or vectors in order to lower his altitude), could have requested to enter the holding

Link break: What should the descent rate be *if* established on the glide slope with a ground speed of 140 Kts. (Pusher Ice Mode, 0° Flaps)? 753 fpm. It appears that the power may have only been minimally added in order to maintain a very slow approach speed and never established on the glide slope! Not established at this point the pilot should have missed the approach.

Link break: Missed approach, talk to somebody.

Link break: Was the pilot going around? Applying power first and a smooth pitch up (or Go-Around mode-EFIS) could have broken this chain.
