PRELIMINARY ACCIDENT REPORT

ACCIDENT REFERENCE: CA18/2/3/8894

AIRCRAFT REGISTRATIONS: ZS-GAA

AIRCRAFT TYPES: PILATUS PC-12/47

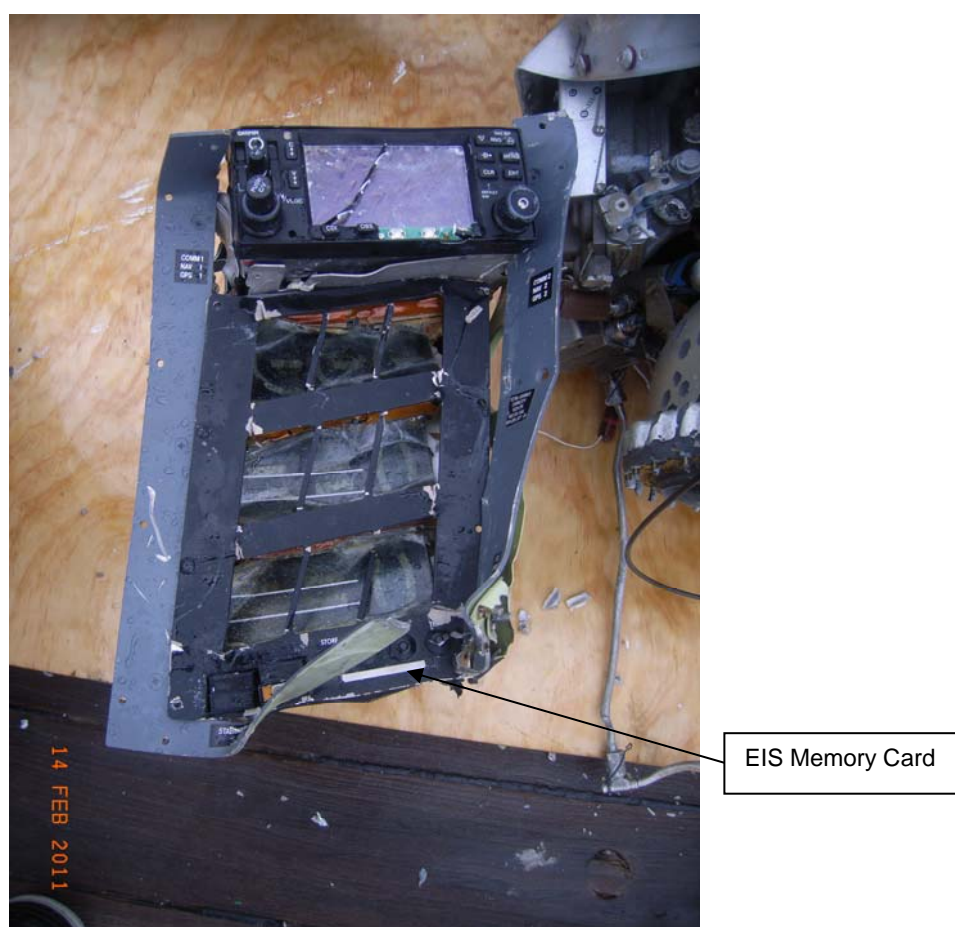
Figure 1. EIS Display

1.11.2 The aircraft was equipped with an Engine Indication System (EIS), which contained a non-volatile memory (NVM) in the form of a memory card. The memory card was normally used to download Engine Condition & Trend Monitoring (ECTM), which records engine trend data, but also engine exceedance data, if applicable. The EIS display was recovered from the sea after several days, and after recovery was immediately rinsed in fresh water.

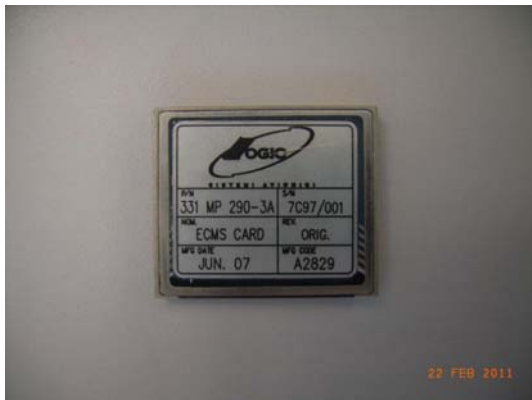
Figure 2. EIS Memory Card

“The EIS memory card most likely sustained internal damage to such an extent that normal data download using the normal tooling was not possible. The reason for this damage was most likely the penetration of salt water into the card itself”.

The actual vendor/manufacturer of the memory card was contacted following the download attempt of the memory card referred to above. They indicated that the memory card was not designed nor manufactured as a waterproof unit and by being exposed to the sea water for several days, the flash chip inside most probably deteriorated/broke, with the result that the downloading/retrieval of data was not possible.

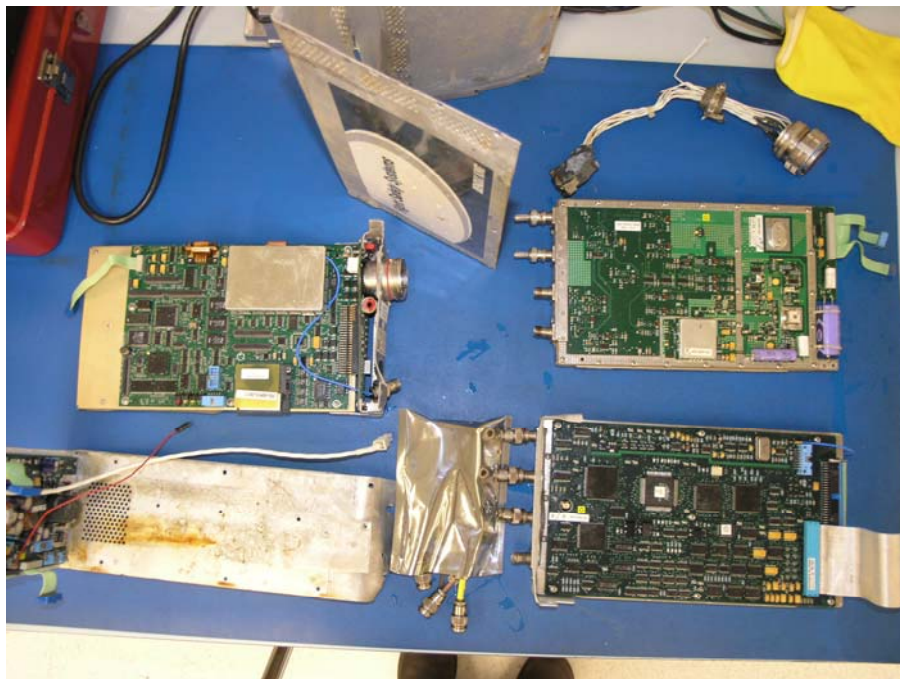
A view of the unit after it was dismantled and cleaned at the Honeywell laboratory.

The EGPWS module installed on ZS-GAA was inoperative (INOP) at the time of the accident due to a failure of the internal Terrain Database. Honeywell has not determined any probable cause for the internal failures as the unit had been submerged in salt water and was mechanically damaged during the accident.”

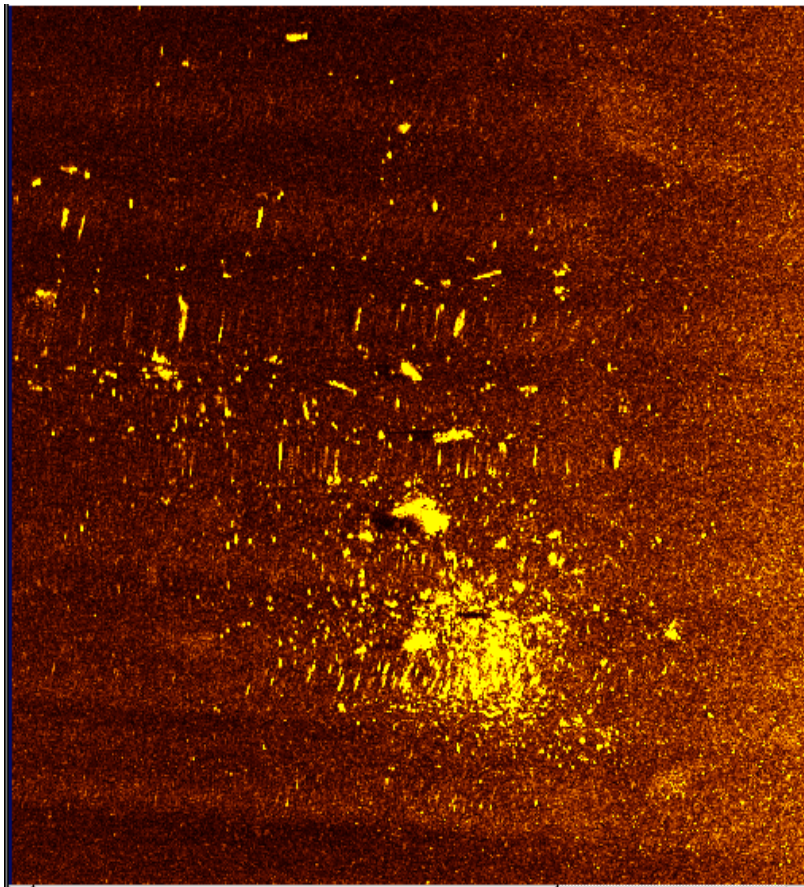
1.12.2 This image (see figure 3 below) was made available by the South African Navy, and indicates the images that were picked up by the side scan sonar that was being utilized in order to locate the wreckage. The image provides reflections and no actual components/parts could be allocated to a certain object as reflected, but it does provide the reader with some insight into the wreckage field.

Figure 3. Side scan sonar image of debris field under the water, courtesy of SA Navy.

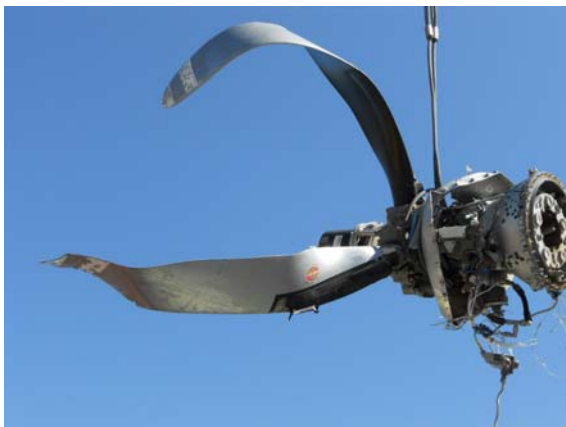
The propeller, with two of the four blades still attached to the hub assembly and the reduction gearbox of the engine were recovered, and so was the engine.

Figure 4. A view of the propeller.

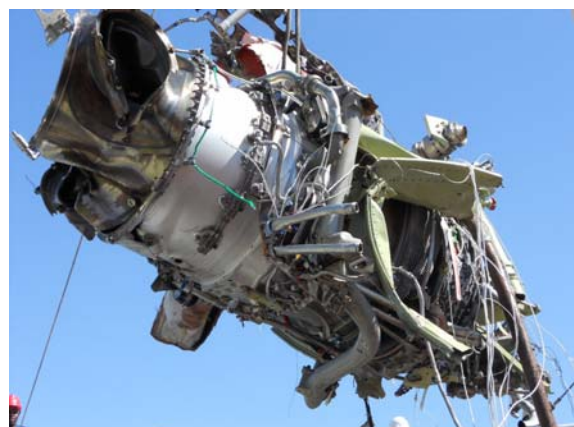
Figure 5. A view of the engine

The engine displayed severe impact and salt water immersion damage, including

“A brief summary of observations, engine displayed deformation to the compressor 1st stage blades and contact signatures to the compressor axial stages, compressor impeller and shroud, compressor turbine, 1st stage power turbine vane ring and shroud, 1st stage power turbine, 2nd stage power turbine vane ring shroud, 2nd stage power turbine, and torsional fracture of the reduction gearbox propeller shaft coupling webs characteristic of the engine producing power at impact, likely in the middle to high power range. There were no indications of any pre-impact mechanical anomalies or dysfunction to any of the components observed.”

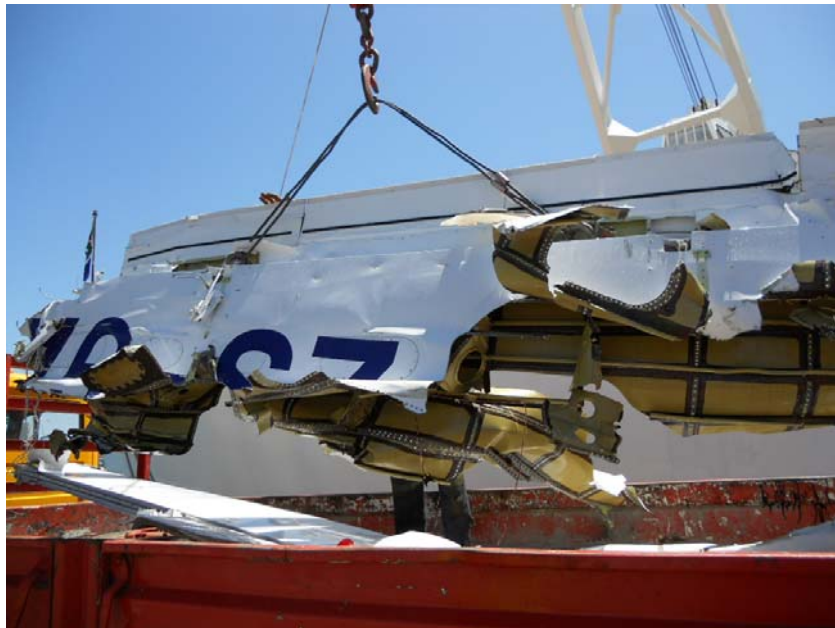
A section of the left wing was recovered (see figure 7). The inner part of the wing up to rib 5 is missing (refer to Figure 8). The outer part of the wing is fractured in the area of rib 16. Except for the wing tip, none of the pieces of this section was found. The inner leading edge is missing and the tank area had burst open. The rear spar of the wing was fractured at the landing gear attachment. Both wing fuselage/wing attachments are missing. No pieces of the left main landing gear were found.

Figure 7: A view of the left wing that was recovered with a section of the flap attached.

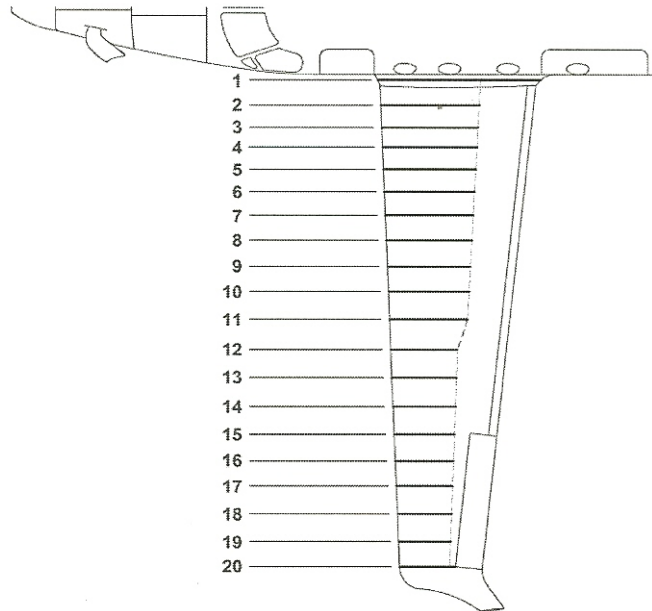
Figure 8. Left wing sections.

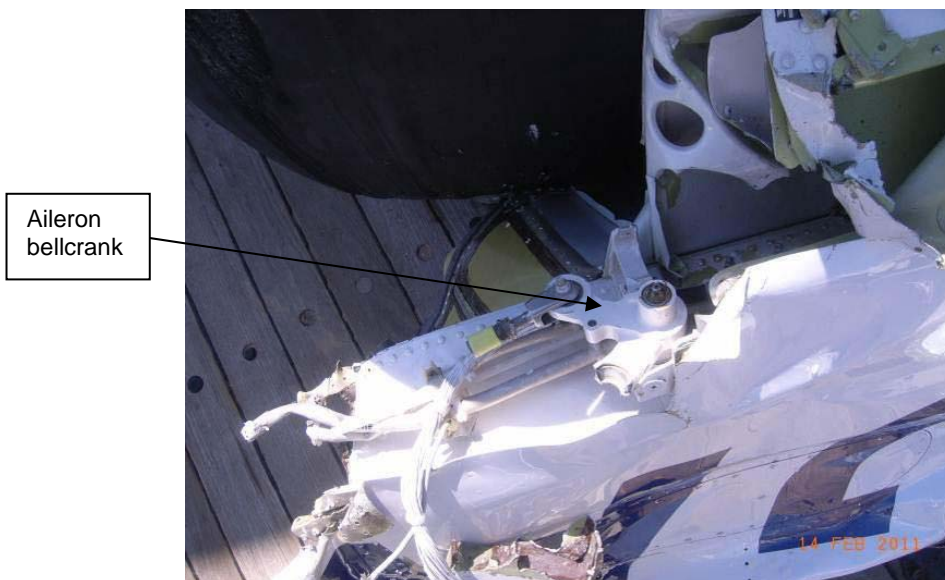
Except for one bellcrank (see Figure 9) (left-hand outer), no other parts of the aileron system, including the surfaces itself, were found. The aileron trim actuator (located on the left side) was not recovered either, therefore aileron control continuity could not be established.

Figure 9. The left-hand outer aileron bell crank.

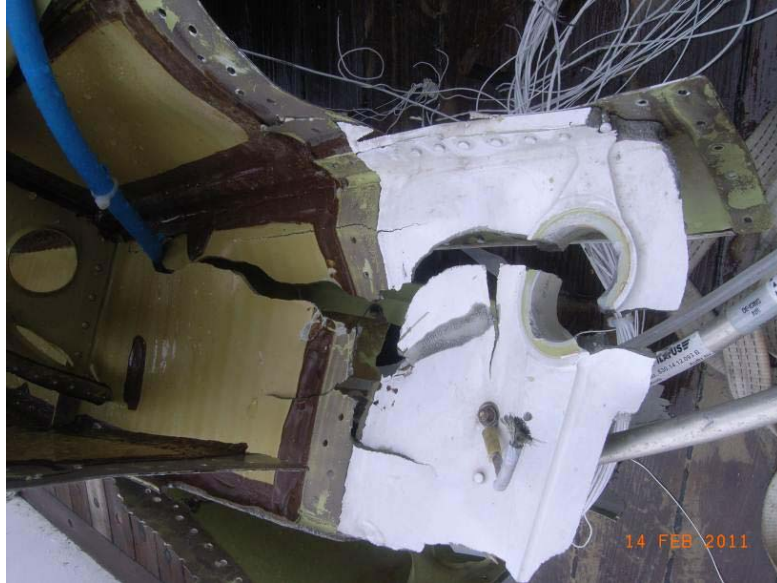
time of impact with 100% certainty. The left-hand side landing gear attachment point at the rear wing spar did not show any signs of torsion (see Figure 10).

Figure 10: Left-hand landing gear attachment point at the wing main spar.

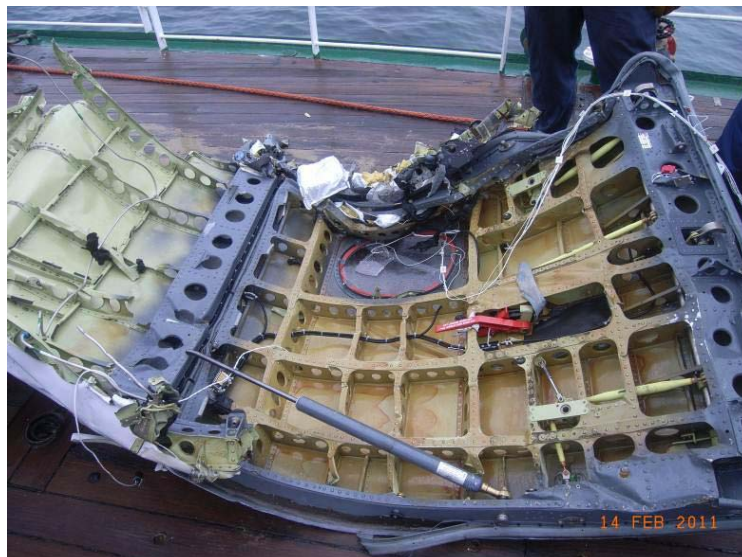
The cargo door area and associated structure were recovered from the sea. The cargo door was found still attached to the hinge on the top fuselage. The 3 hooks were free to rotate, as the locking mechanism reflected damage to the individual units. One shoot bolt was found out and jammed, which was an indication that the door was closed and locked at the time of impact.

Figure 11. Cargo door with shoot bolt.

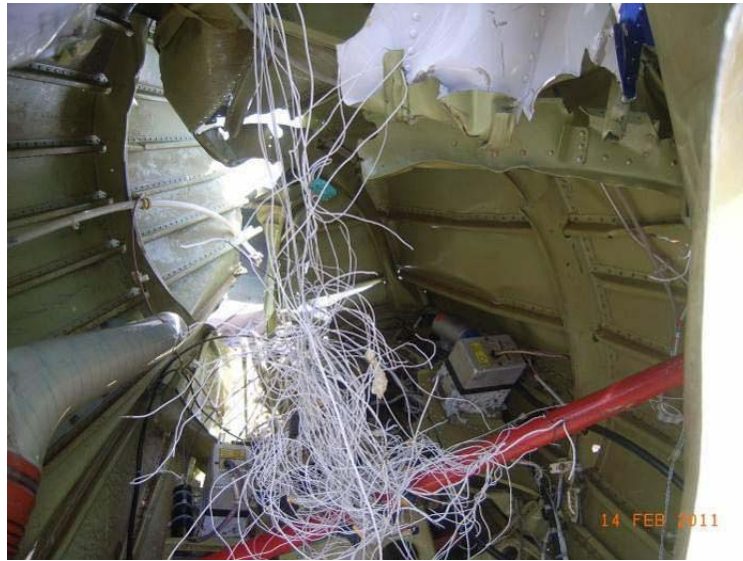
The forward section of the empennage, the vertical stabiliser including the rudder as well as the horizontal stabiliser were recovered from the sea. The rudder and flight control cables were still attached to the horizontal stabiliser with minor damage observed. The cables were found to have fractured under tension/overload. The horizontal stabiliser had separated at its attachment to the vertical stabiliser with substantial damage observed on the right-hand surface, which could be associated with impact. The elevator was still attached to the horizontal stabilizer and the hinges were damaged by impact forces. Approximately half of the left-hand surface was missing; this was associated with impact damage. The push-pull rod from the bell-crank to the elevator was found to be fractured and bent. The control cables were still attached to the bell-crank. The cables were found to have fractured in overload mode. Up to this point, continuity was established. As no other pieces of

Figure 14. Forward section of the empennage.

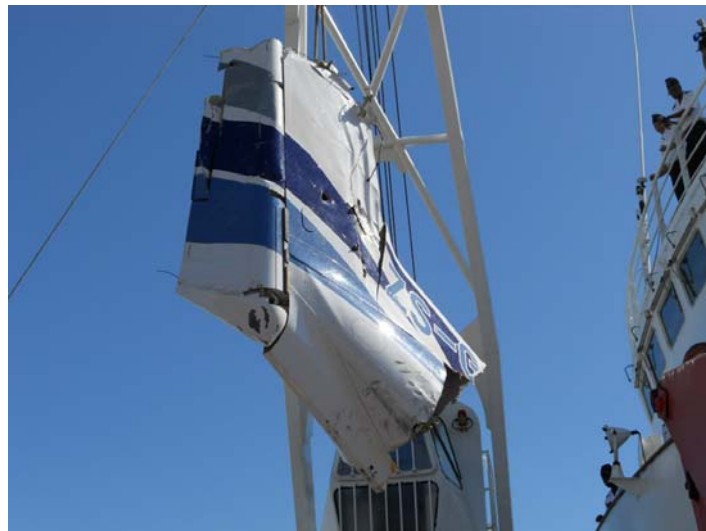
Figure 15. The vertical stabiliser, including the rudder.

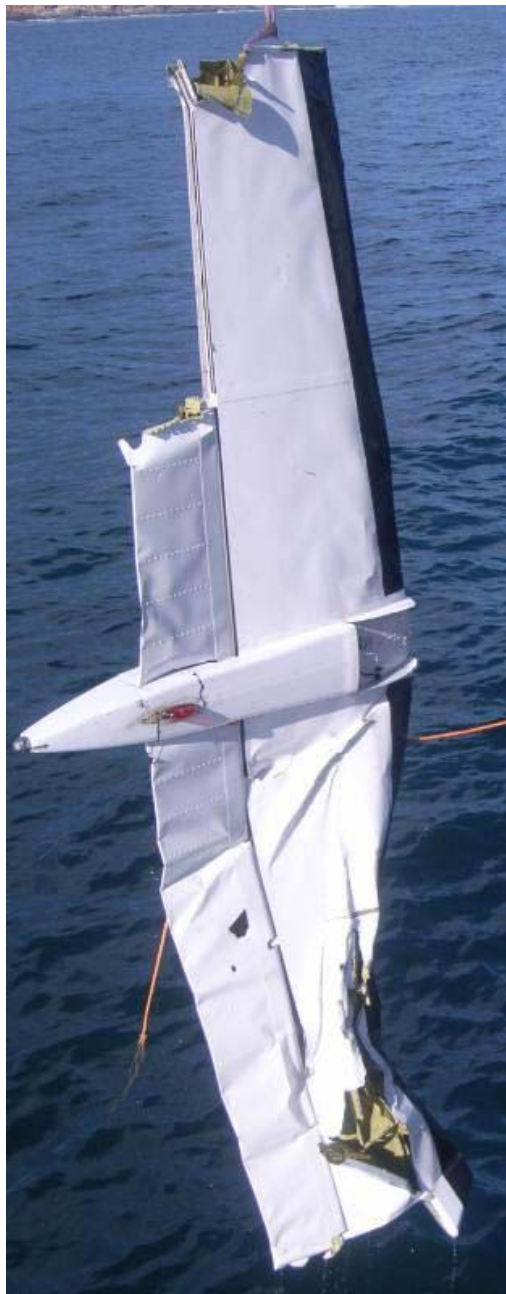
Figure 16. Horizontal stabiliser

The horizontal tail plane of the aircraft was recovered from the sea. It was noted that the right horizontal stabilizer had suffered some impact damage on the leading edge, however the right elevator assembly remained attached to the stabilizer surface. It was, however, noted that the outer section of the left elevator had failed and was unaccounted for. The horizontal tail plane was inspected by a metallurgist and the left elevator assembly was removed in order to establish the failure of the flight control surface.

“The possibility of failure due to in-flight flutter of the elevator was contemplated. However, the results from this investigation point towards impact rather than flutter-induced failure during operation, based on the following observations:

- (i) In the majority of cases where flutter resulted in the failure of control surfaces during operation, the entirety of the surface will show comparable damages. In this case the right-hand section of the elevator failed to reveal the same.*
- (ii) The top and bottom elevator movement stops revealed no clear evidence of excessive impact wear or damages.*
- (iii) The elevator counter weight proved to be in relative good condition with no clear indications of exposed train typical to flutter inputs.*
- (iv) The connecting bracket fracture surface points towards failure on impact and not during operation, which may have resulted in loss of elevator control and/or flutter thereof.*

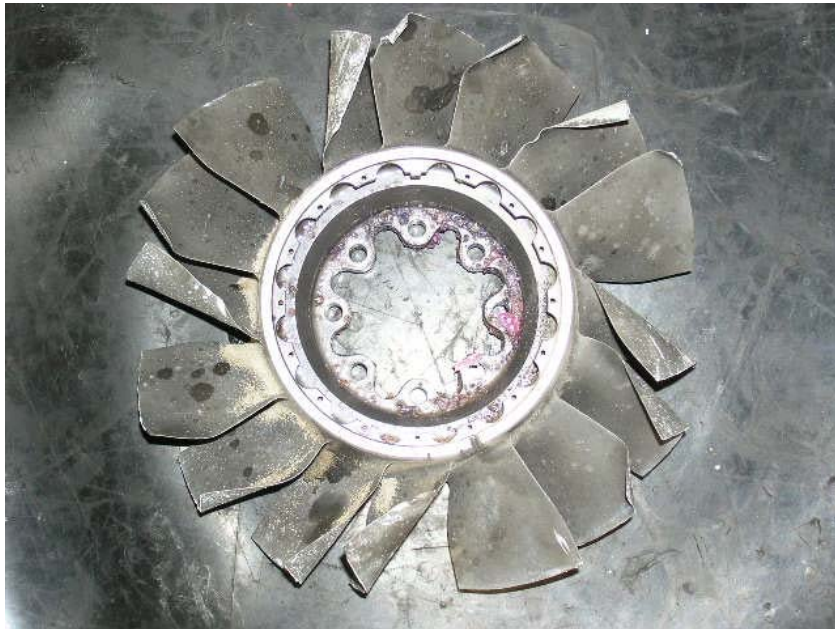
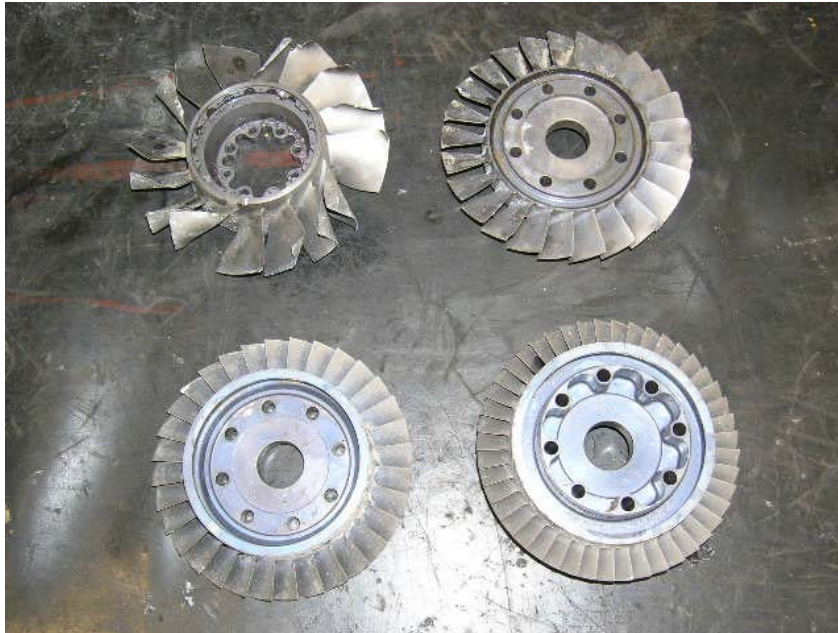
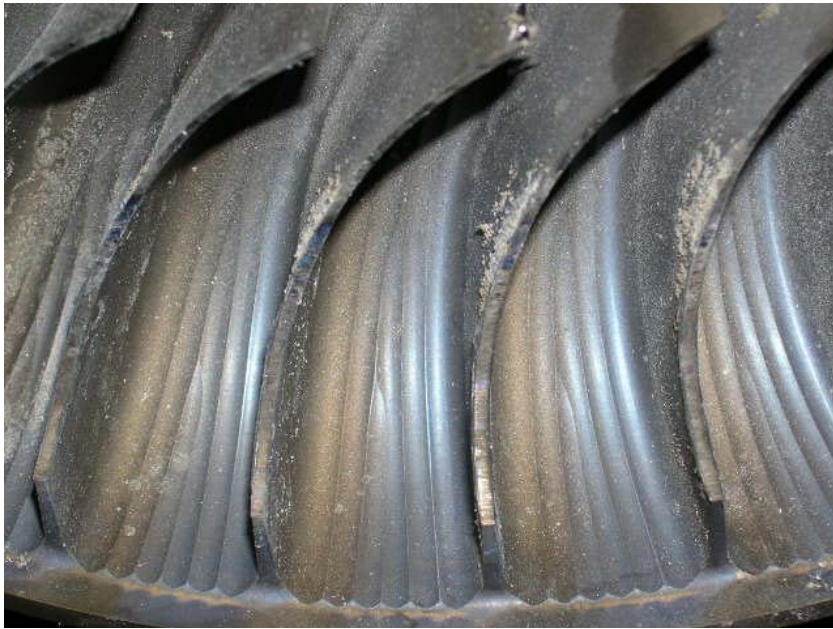
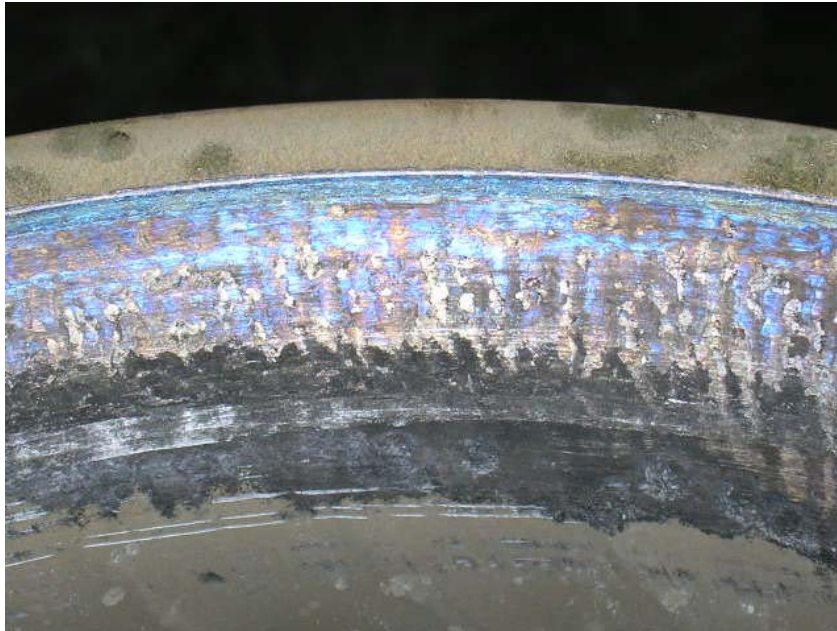
Compressor Discs and Blades: The 1st stage blade airfoils were deformed randomly forward and away from the direction of rotation. The blade airfoil leading edges displayed nicks and deformation. The 2nd stage blade airfoils displayed slight nicks and deformation. The 3rd and 4th stages were intact. Please refer to photos No. 2 to 5.

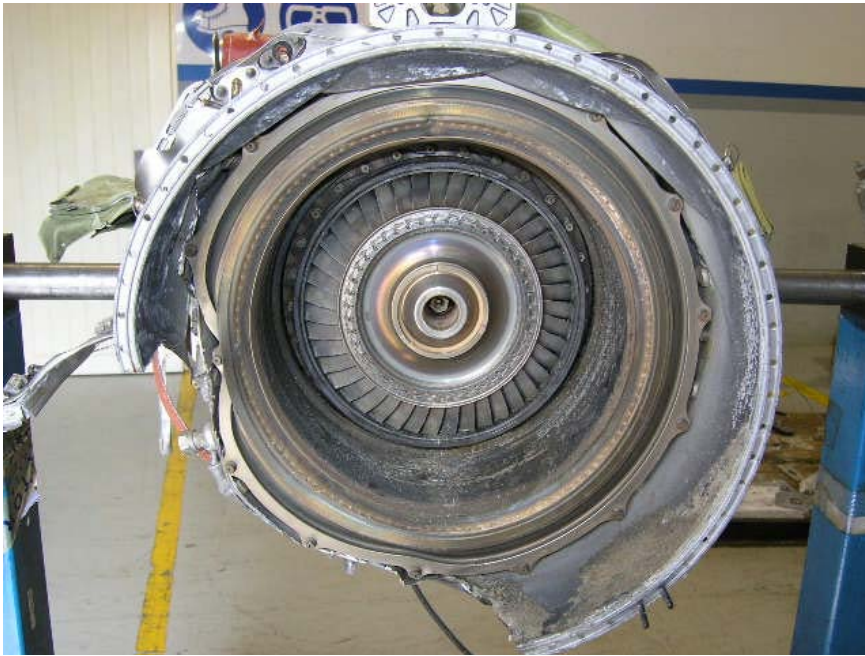
Combustion Chamber Liner: Displayed no indications of operational distress. The outer liner flame pattern indications appeared normal. Please refer to photo No. 6.

Photo No. 6
Combustion chamber liner and compressor turbine, in-situ.

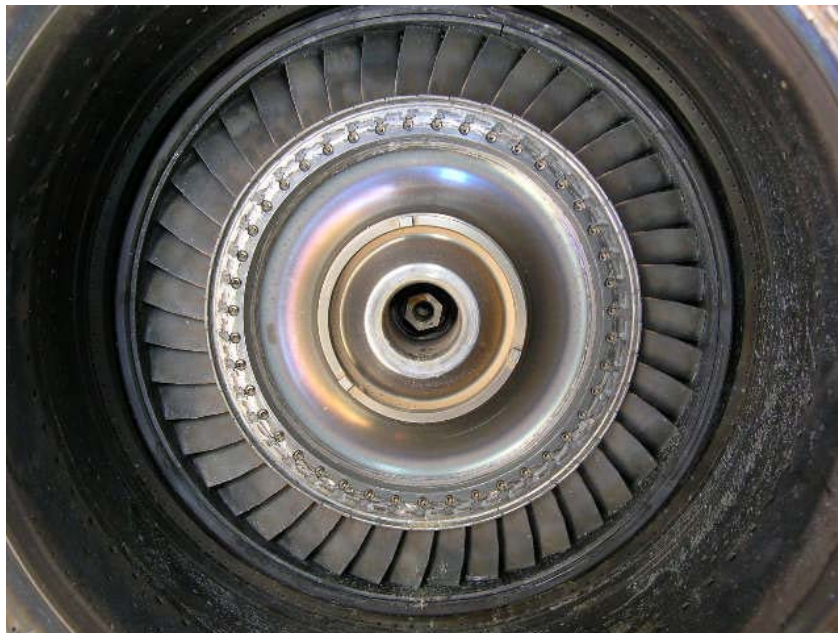
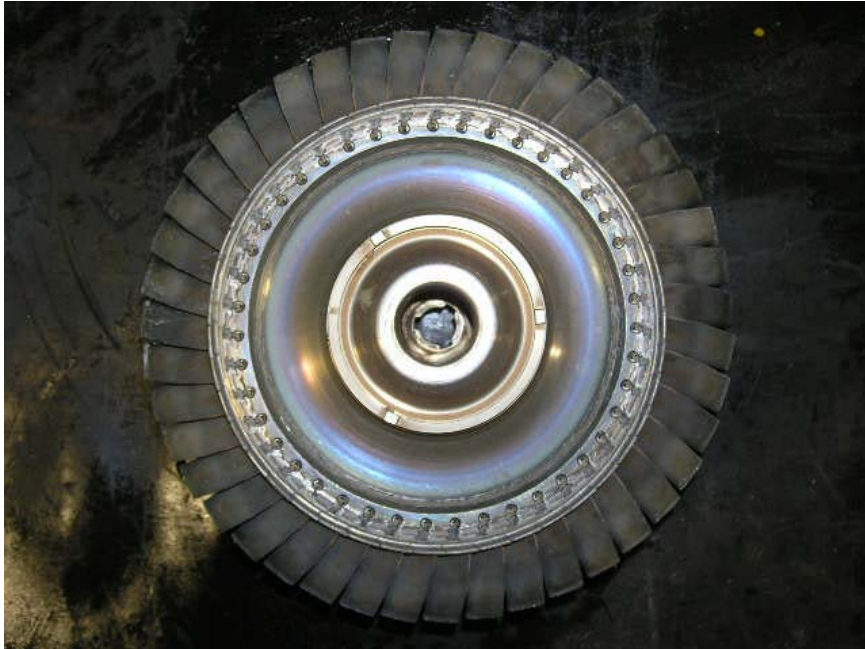
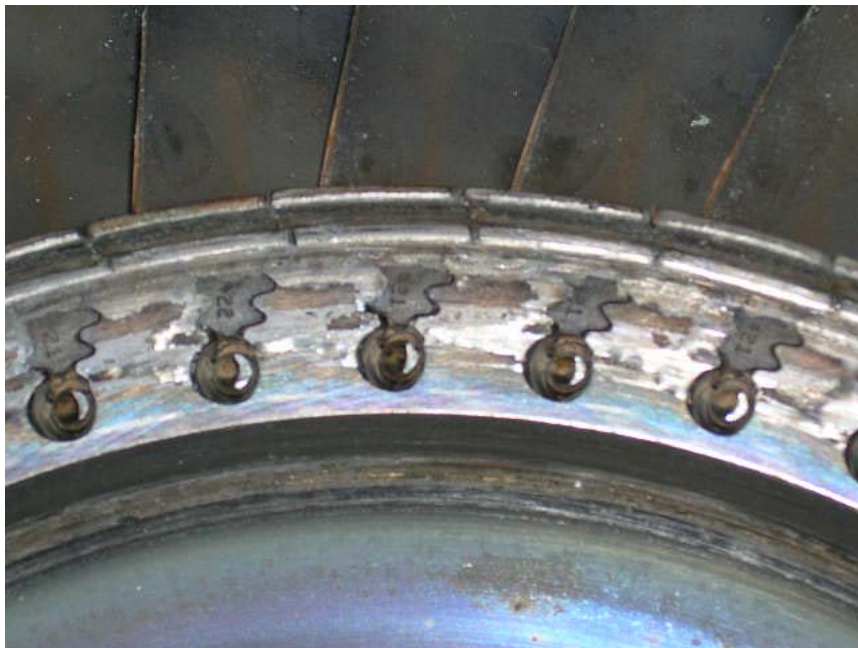
Compressor Turbine: The blade airfoils displayed no indications of distress. The upstream side blade platforms displayed circumferential rubbing due to contact with the compressor turbine vane ring inner drum. The downstream side blade platforms and disc outer rim were circumferentially machined due to contact with the 1st stage power turbine vane ring. The hub face was circumferentially rubbed due to contact with the interstage baffle. Please refer to photos No. 7 to 9.

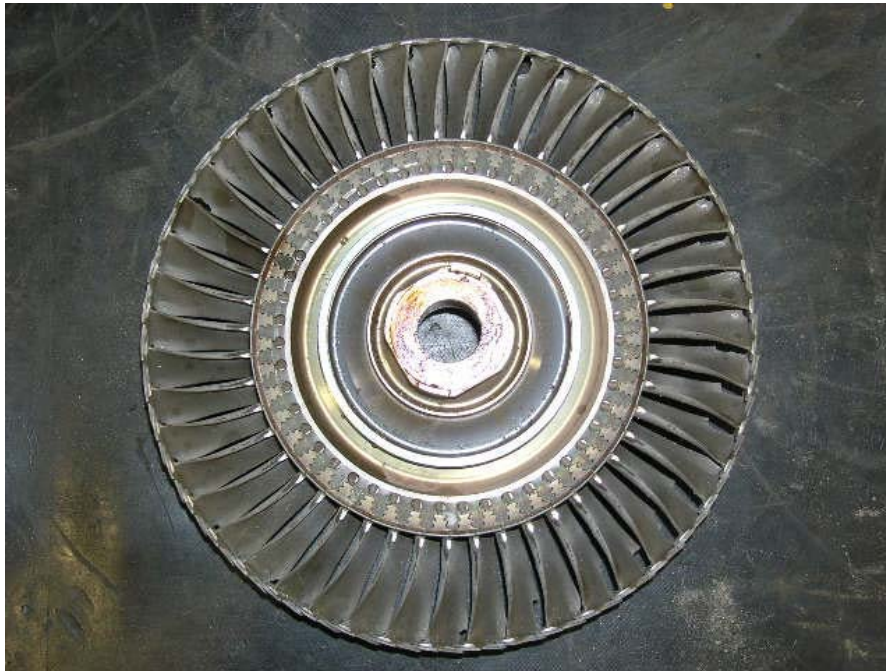
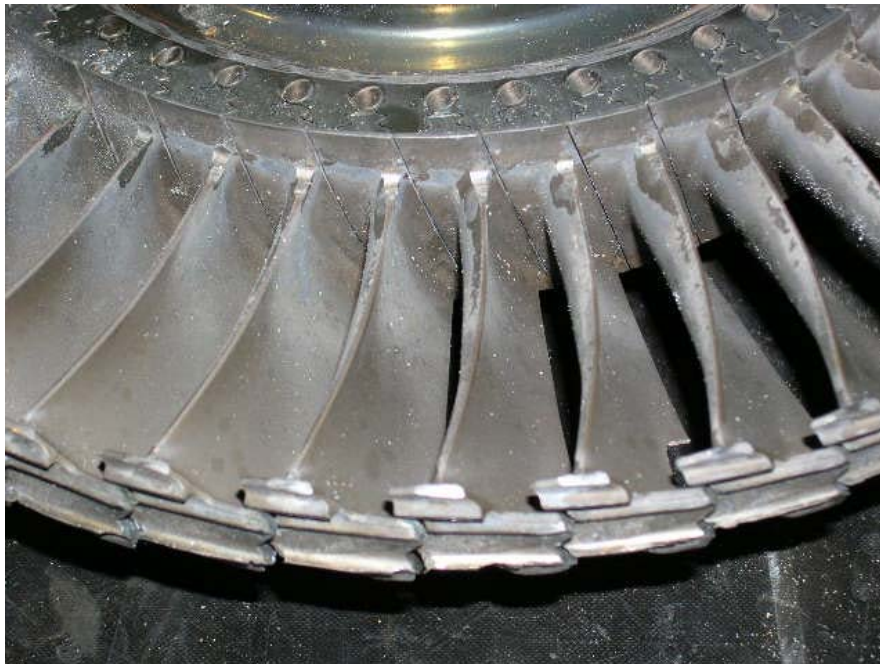
1st Stage Power Turbine: The upstream side blade roots and the blade tip shrouds displayed circumferential rubbing and machining due to contact with the 1st stage power turbine vane ring. The downstream disc outer rim and blade outer spans were circumferentially rubbed, and the outer spans deformed and fractured, due to contact with the 2nd stage power turbine vane ring. The blade tips were circumferentially rubbed due to contact with the shroud. Please refer to photos No. 10 and 11.

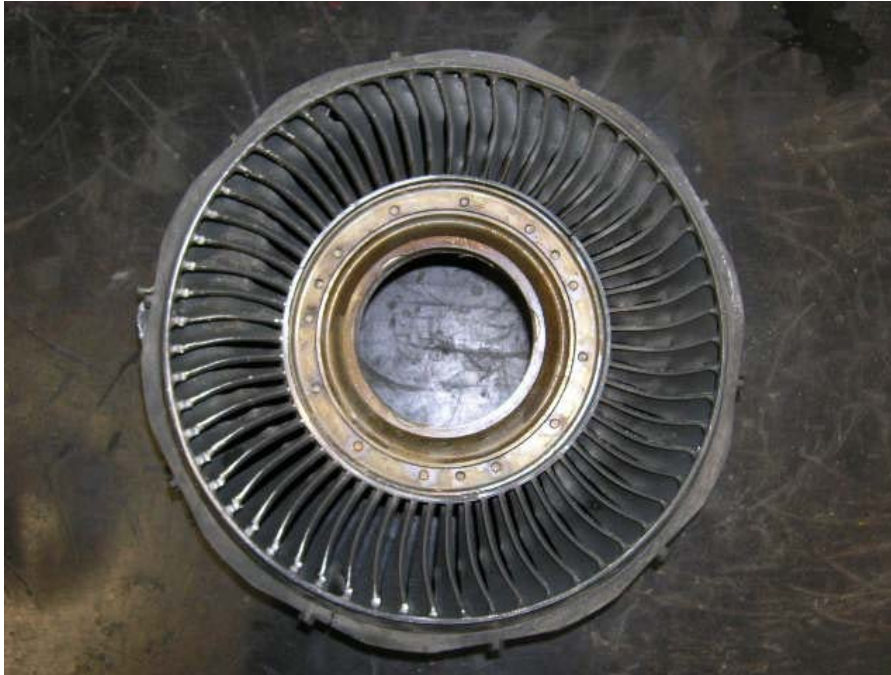
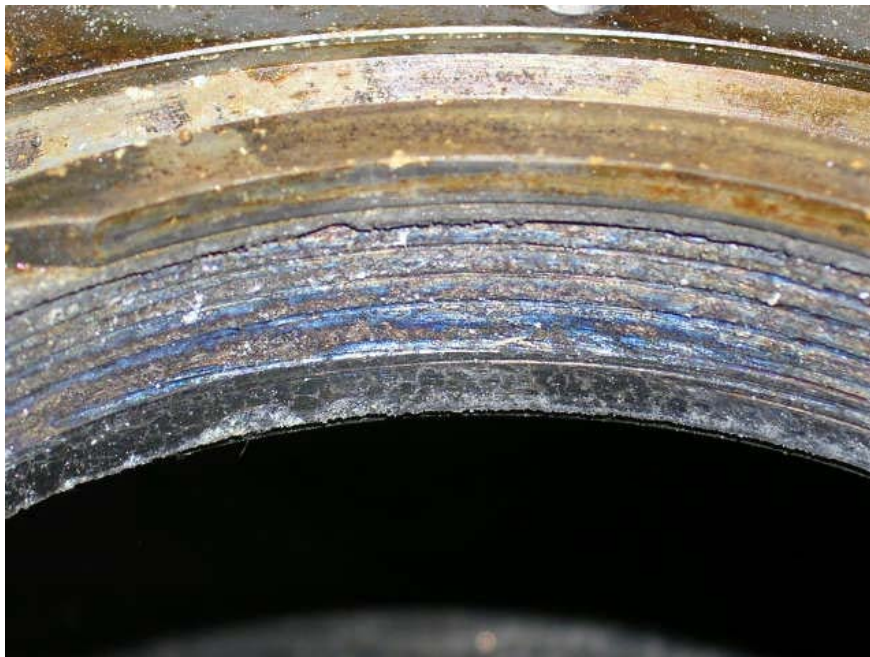
2nd Stage Power Turbine Vane Ring: The vane airfoil leading edges and vane ring inner drum were circumferentially rubbed and machined from the approximate 6:00 to 10:30 positions due to contact with the 1st stage power turbine. The vane ring downstream side displayed heavy circumferential rubbing and machining, with the heaviest concentration from the approximate 1:00 to 3:00 positions due to contact with the 2nd stage power turbine. The interstage abrasible air seal displayed heavy

Photo No. 12
2nd stage power turbine vane ring, upstream side.

Photo No. 13
Interstage airseal detail, approximate 9:00 position.

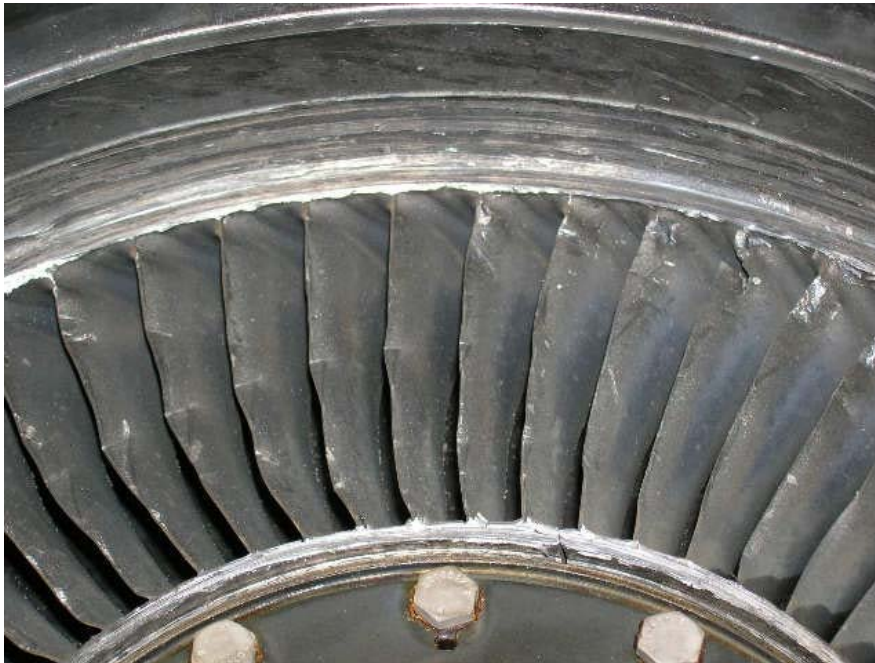
Photo No. 14

2nd Stage Power Turbine Shroud: Displayed heavy circumferential rubbing due to contact with the 2nd stage power turbine blade tips. Please refer to photo No. 14.

2nd stage power turbine vane ring downstream side and shroud, approximate 2:00 position

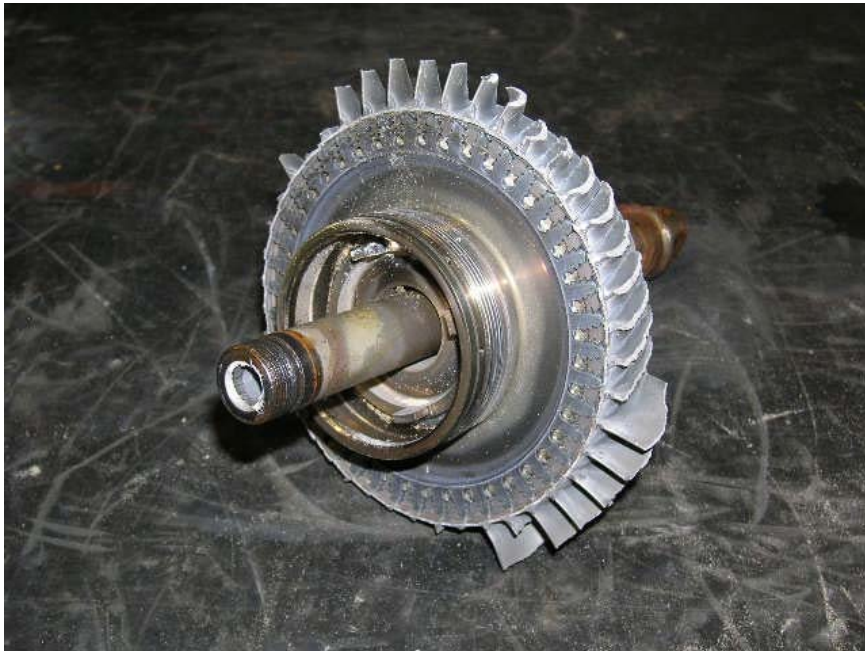
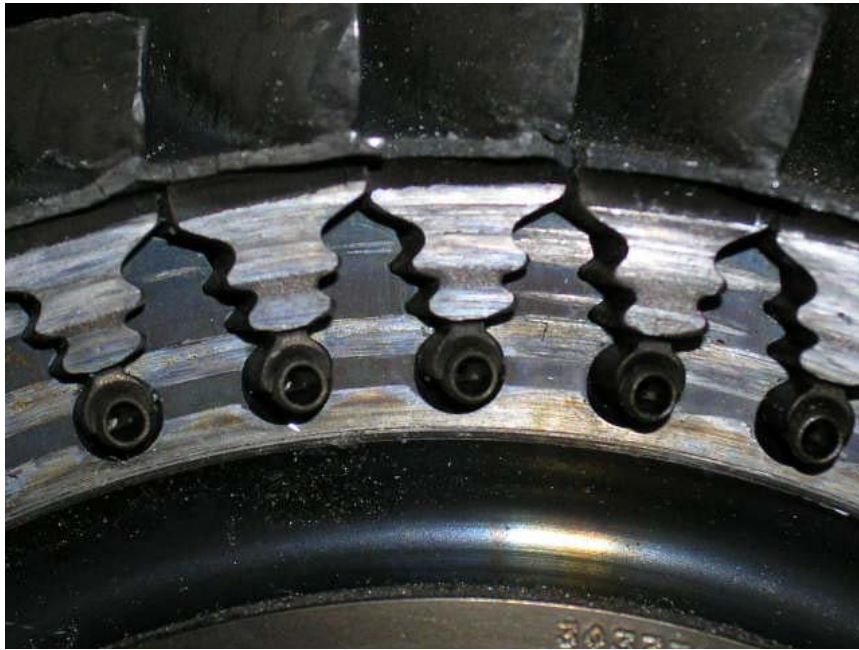
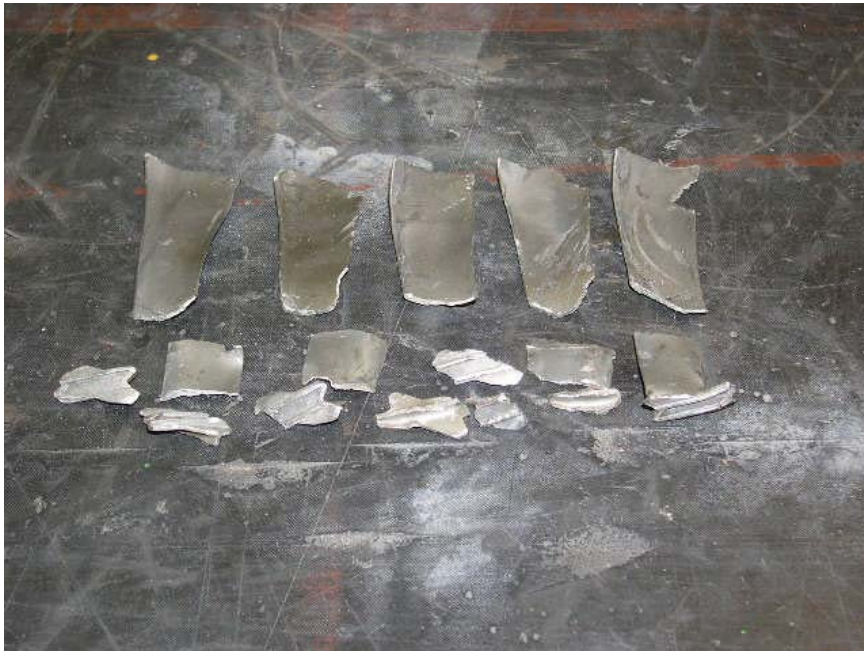
2nd Stage Power Turbine: The blade airfoils were circumferentially fractured at heights varying from the root to approximately 1/4 span due to contact with the duct, shroud, and 2nd stage power turbine vane ring. Fractured blade material remained in the exhaust duct. The recovered blade tips displayed circumferential rubbing. The upstream side blade platforms displayed circumferential machining due to contact with the vane ring. The downstream side blade platforms and disc face displayed circumferential rubbing due to contact with the power turbine shaft housing and exhaust duct inner shroud. Under unaided visual and macroscopic inspection all of the blade fractures displayed course dendritic features and displayed no indications of fatigue or other progressive fracture mechanism. Please refer to photos No. 15 and 16.

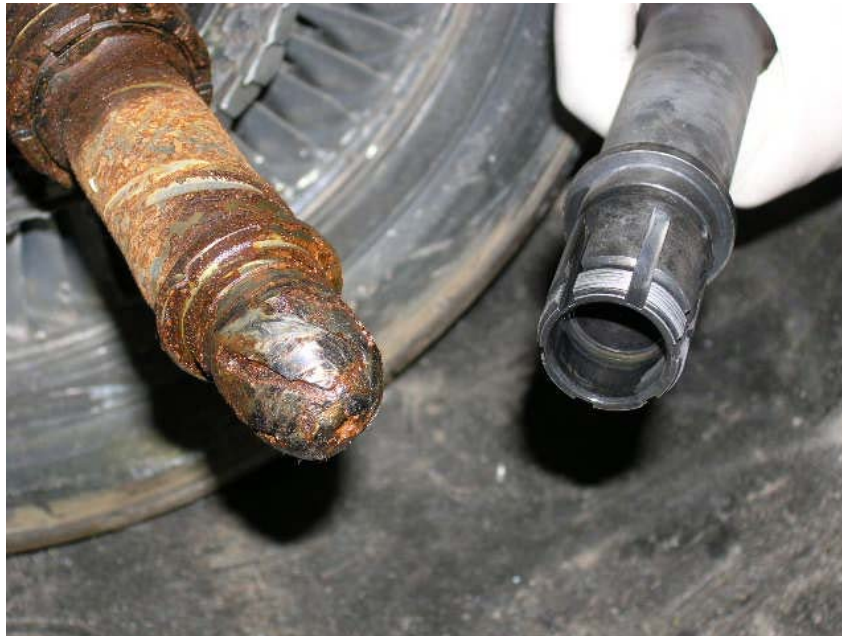
Power Turbine Shaft and Shaft Housing: The power turbine shaft was fractured from the reduction gearbox coupling. The shaft face displayed severe circumferential rubbing and deformation. The power turbine shaft housing was not recovered. The exhaust duct inner shroud displayed circumferential scoring due to contact with the 2nd stage power turbine. Please refer to photo No. 18.

Photo No. 18
Power turbine shaft forward section compared to exemplar shaft.

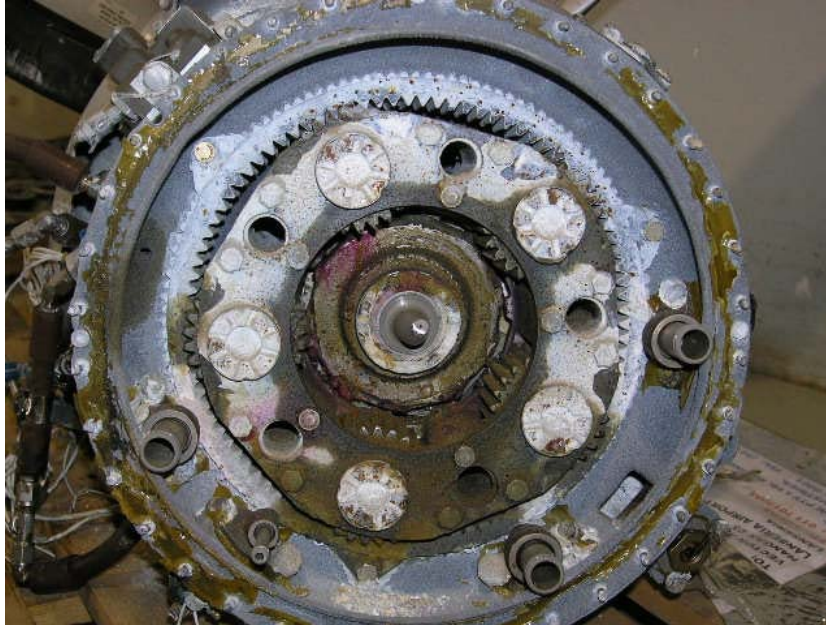
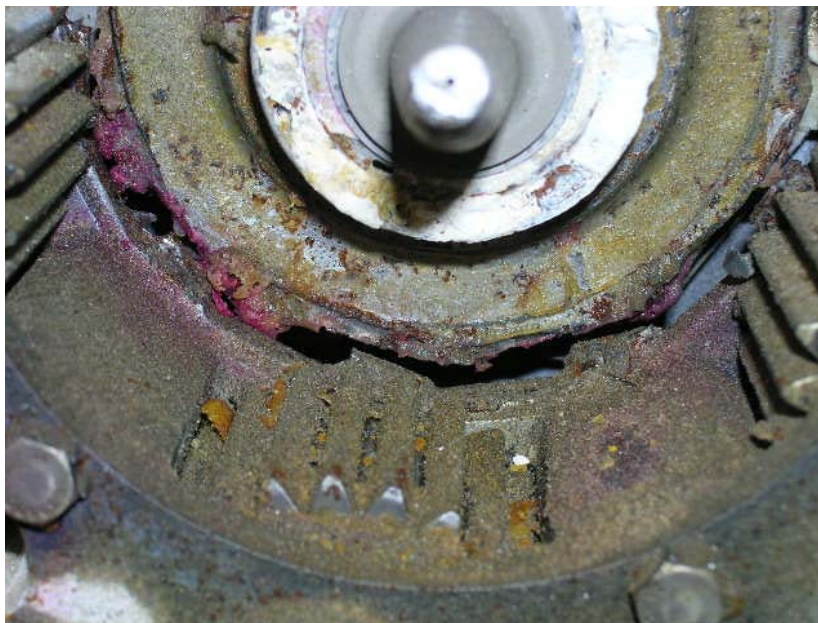
The 2nd stage gearing was observed in-situ in the reduction gearbox forward housing. The gearing displayed severe corrosion damage. The 2nd stage planet gear carrier to propeller shaft spline mounting webs was fractured in torsion. The fractured webs displayed counter-clockwise torsional deformation. The reduction gearbox rear housing and 1st stage gearing were not recovered. Please refer to photos No. 19 and 20.

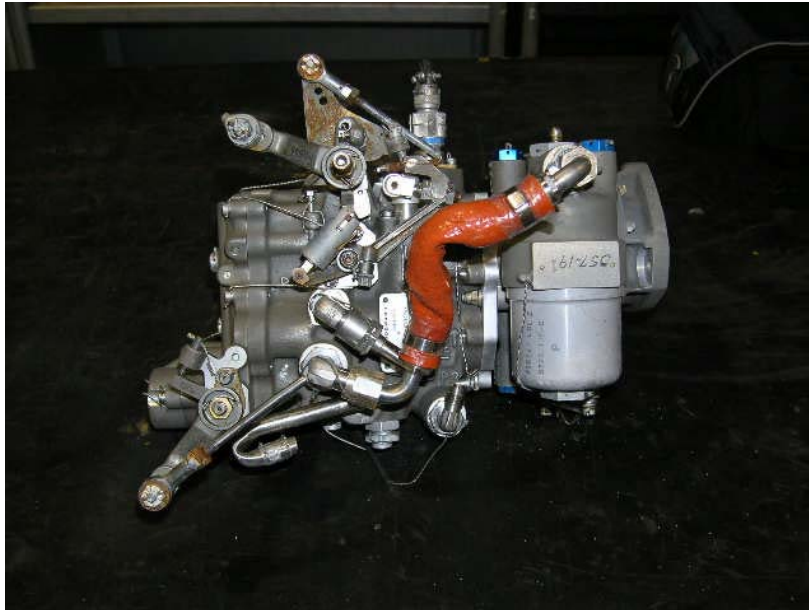
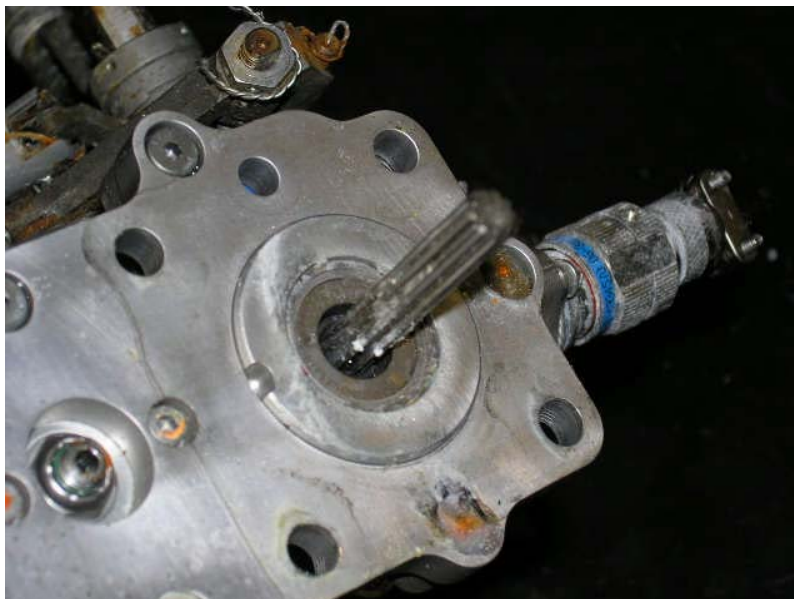
Salt water immersion damage precluded evaluation of the controls and accessories. The fuel control unit was separated from the high pressure fuel pump for inspection of the governor drive shaft. The shaft was intact and could be rotated by hand. Please refer to photos No. 21 and 22.
