UNITED STATES AIR FORCE
AIRCRAFT ACCIDENT INVESTIGATION
BOARD REPORT

U-28A, T/N 07-0736
HURLBURT FIELD, FLORIDA

LOCATION: NEAR CAMP LEMONNIER, DJIBOUTI

DATE OF ACCIDENT: 18 FEBRUARY 2012

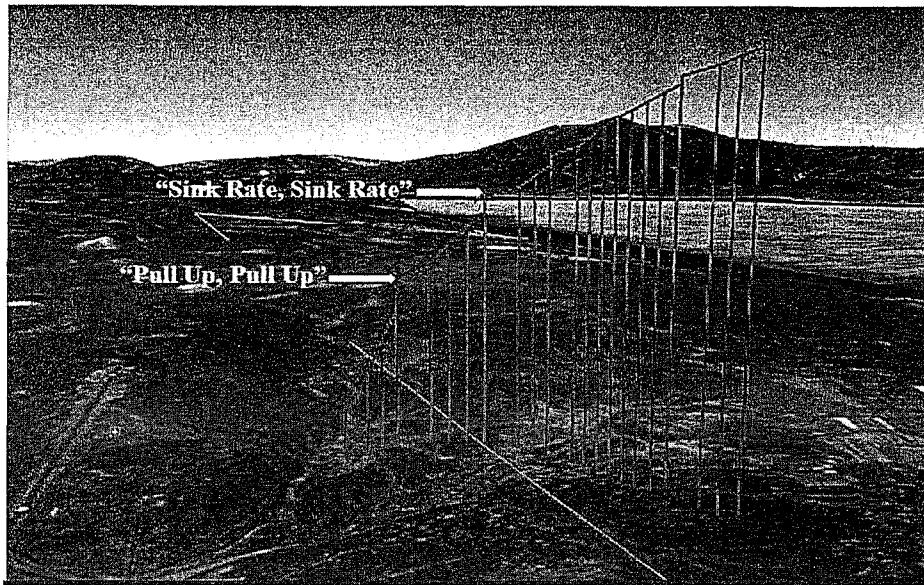
At 1917:52, and at 2,972 ft MSL, the onboard EGPWS shows a descent of 2,443 fpm and a 24.5 degree right turn with 195 knots ground speed. (Tab JJ-9) The EGPWS shows data every second and shows the MA in a relatively constant descent, a decreasing right turn, and decreasing ground speed for ten seconds. (Tab JJ-9) At 1918:04L, the MA enters into a steadily increasing left bank eventually reaching 55 degrees, while increasing the descent rate from 2,985 fpm to 11,752 fpm, and decreasing the ground speed from 182 knots to 165 knots. (Tab JJ-9) Approximately seven seconds prior to impact, the EGPWS emitted an aural warning to the MC of "Sink Rate, Sink Rate," advising the MC that there was an excessive descent rate occurring. (Tab JJ-9) This warning occurred at 1,800 ft MSL, approximately 1,600 ft above ground level (AGL), with an approximate descent rate of 5,400 fpm. (Tab JJ-9) Another warning was issued by the EGPWS approximately four seconds prior to impact that instructed the MC to "Pull up, Pull up." (Tab JJ-9) This warning occurred at 1,302 ft MSL, approximately 1,102 ft AGL, with a 8,000 fpm descent rate and 174 knots ground speed. (Tab JJ-9) The last EGPWS data for the MA prior to impact is at 1918:18L and shows the MA was in a 55 degree left bank, 11,752 fpm descent rate, and at 165 knots ground speed. (Tab JJ-9) The times on the EGPWS are running clock time. To have accurate times, the radar track data, EGPWS data, and radio transmissions were compared to correlate the times to a synchronized time. (Tab JJ-3)

Figure 1. Descent profile provided by Enhanced Ground Proximity Warning System, looking west. (Tab J-89)

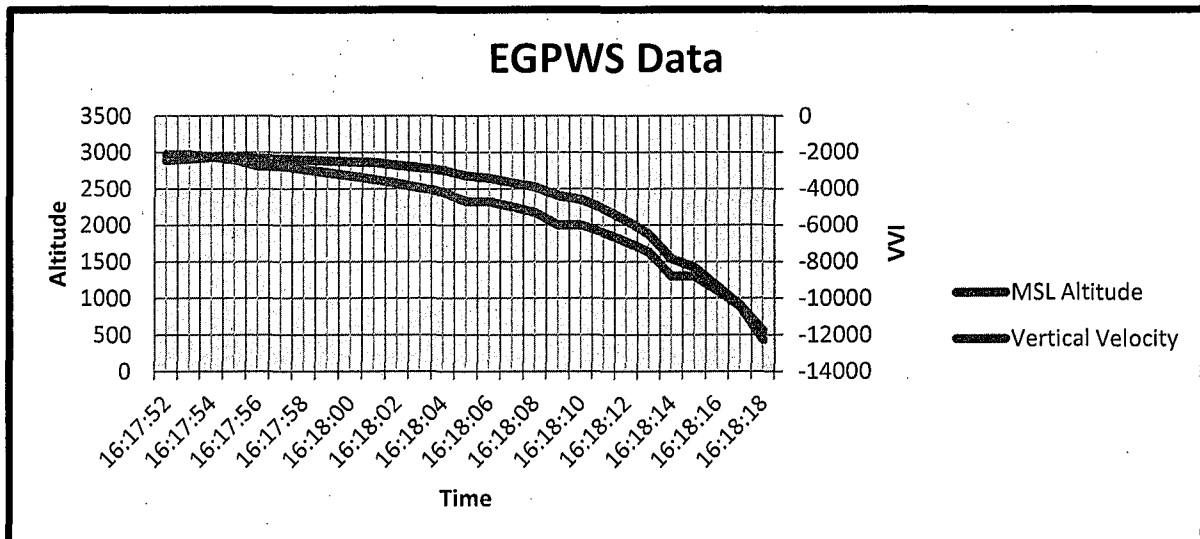
Figure 2. Enhanced Ground Proximity Warning System Data showing Altitude and Decent Rate in feet per minute. (Tab JJ-9)

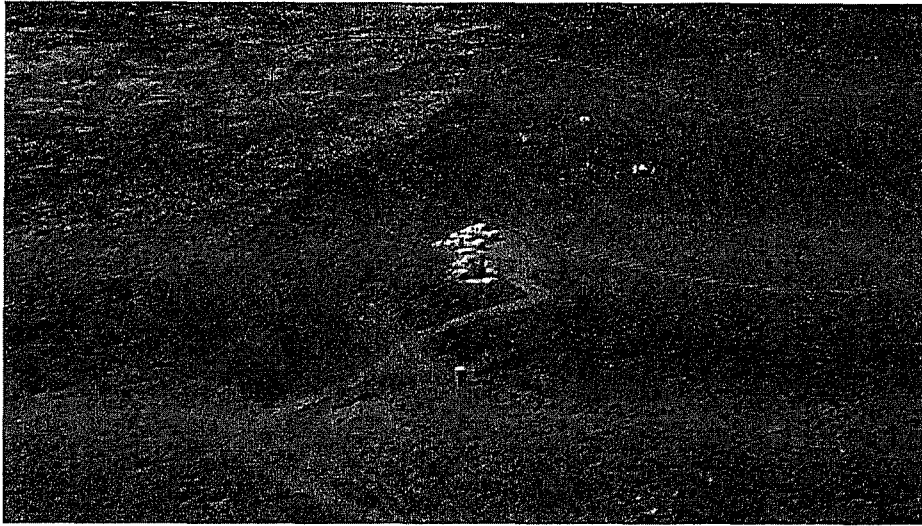
The MA impacted the ground five miles southwest of Ambouli International Airport in an uninhabited and remote location strewn with boulders up to a two to three of feet in diameter, at North 11° 31.61' East 043° 04.41', 265 ft MSL. (Tab N-13) After initial impact, most of the MA cleared the ridgeline before breaking apart.

Figure 3. Aerial view of crash site from CH-53, looking west northwest.

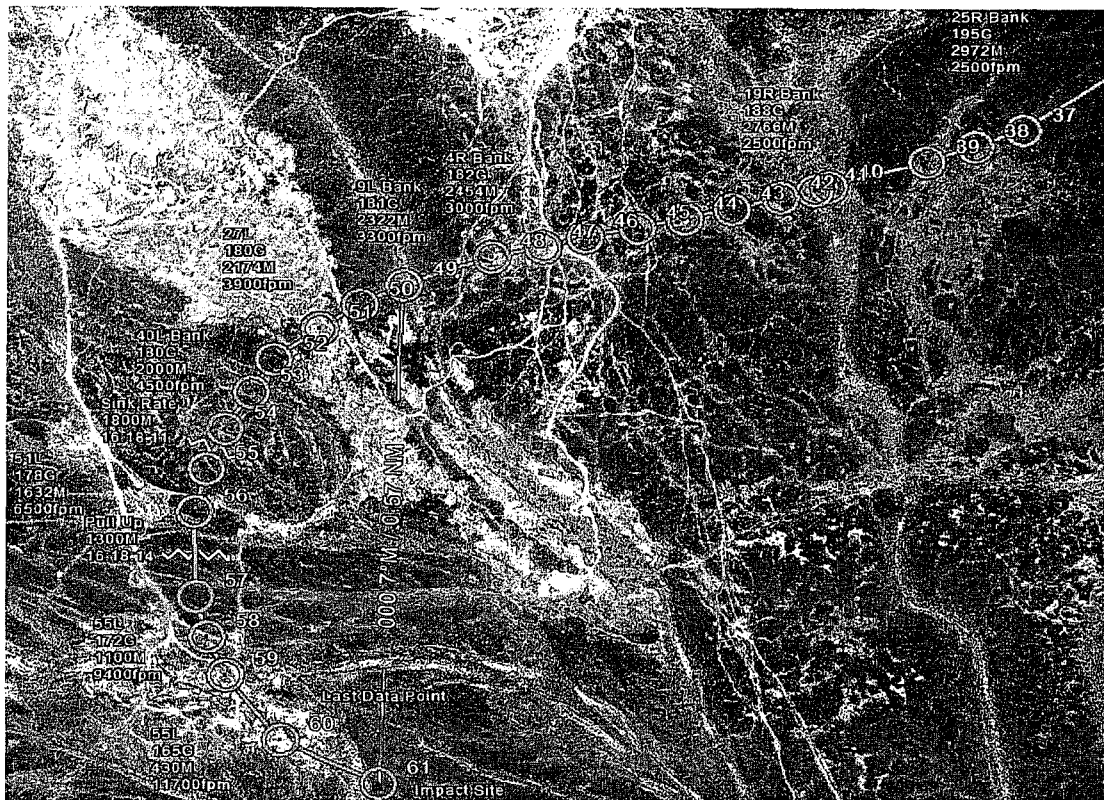
Pitch Trim: After running a nose down pitch trim runaway scenario, an unrecognized pitch trim runaway matches the profile flown by the MA but analysis of the pitch trim actuator by Pilatus showed the pitch trim in a neutral position at impact. (Tab HH-21)

Figure 4. MA Descent profile from 2972 ft MSL to impact. (Tab JJ-9)
