PRELIMINARY ACCIDENT REPORT

ACCIDENT REFERENCE: CA18/2/3/8894

AIRCRAFT REGISTRATIONS: ZS-GAA

AIRCRAFT TYPES: PILATUS PC-12/47

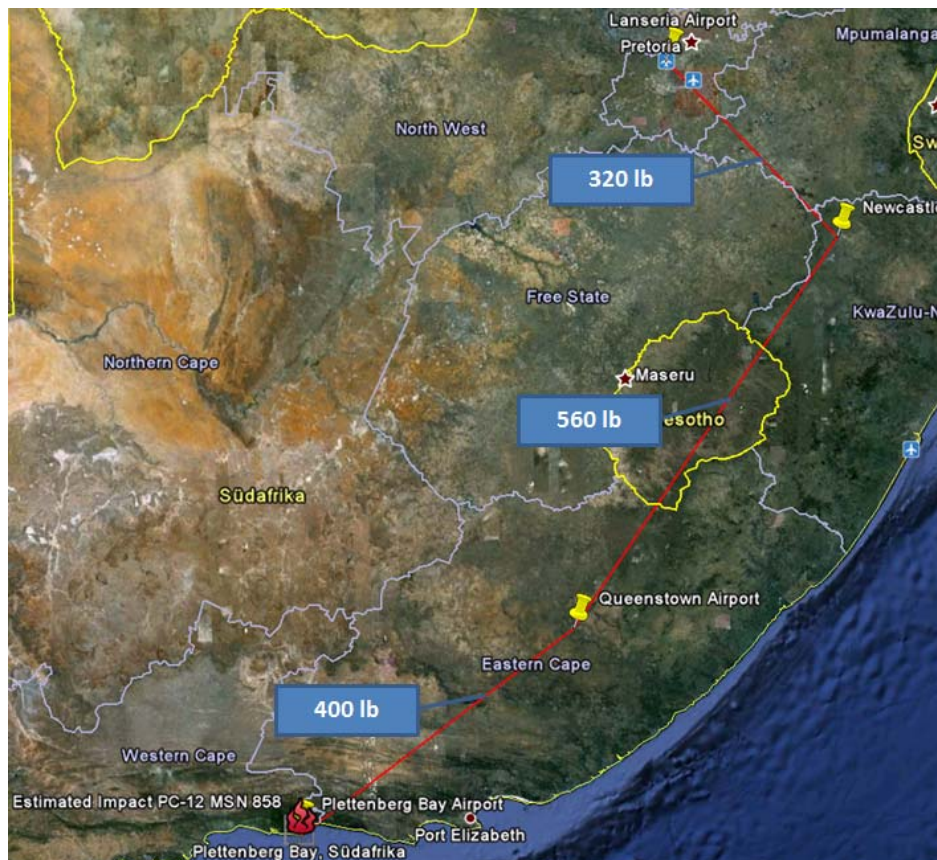
disappeared from radar at approximately 1433.31Z. The Google Earth map below displays the route that was flown by the aircraft on 8 February 2011. The blue block values reflect the estimated fuel consumption for each leg flown, based on data that was obtained from the aircraft flight folio, which was recovered from the sea (the average fuel consumption used for these calculations was 400 pounds per hour).

This Google Earth map displays each leg of the flight and associated fuel consumption.

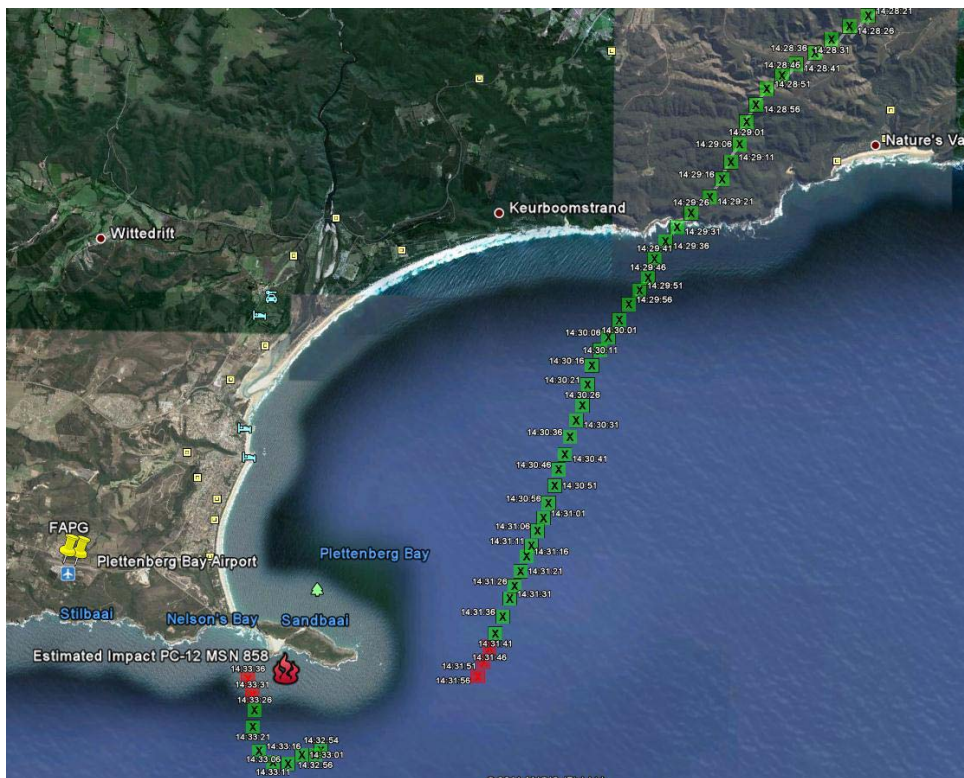
- 1.1.6 Radar footage was obtained for the accident aircraft (ZS-GAA) as well as a Cessna Citation that had landed at FAPG at approximately 1210Z, $\pm 2\frac{1}{2}$ hours prior to the expected time of arrival of the accident aircraft. It is clear from the radar track of the accident aircraft, which had approached Plettenberg Bay from the north-east, that the crew had flown a different approach to that of the Cessna Citation crew, which also approached the aerodrome from the north-east (inbound from FALA to FAPG). The Cessna Citation crew joined overhead the aerodrome and then flew the cloud-break procedure for runway 30 twice, prior to landing at FAPG. According to a statement that was obtained from both crew members of the Cessna Citation, they initiated a go-around on their first approach due to limited forward visibility, associated with low cloud and rain while on final approach for Runway 30. The accident aircraft approached Plettenberg Bay from the north-east and between Keurboomstrand and Nature's Valley descended over the sea in a south-westerly direction for a distance of approximately 7.3 nautical miles (nm), which was followed by a right turn around the Robberg Nature Reserve point (see radar trajectory below). Prior to radar coverage being lost with the aircraft there was no indication that the crew had initiated any change in course, which could be associated with a diversion to George aerodrome (FAGG).

A clip of the radar footage, reflecting the accident aircraft's approach path for an intended landing at FAPG.

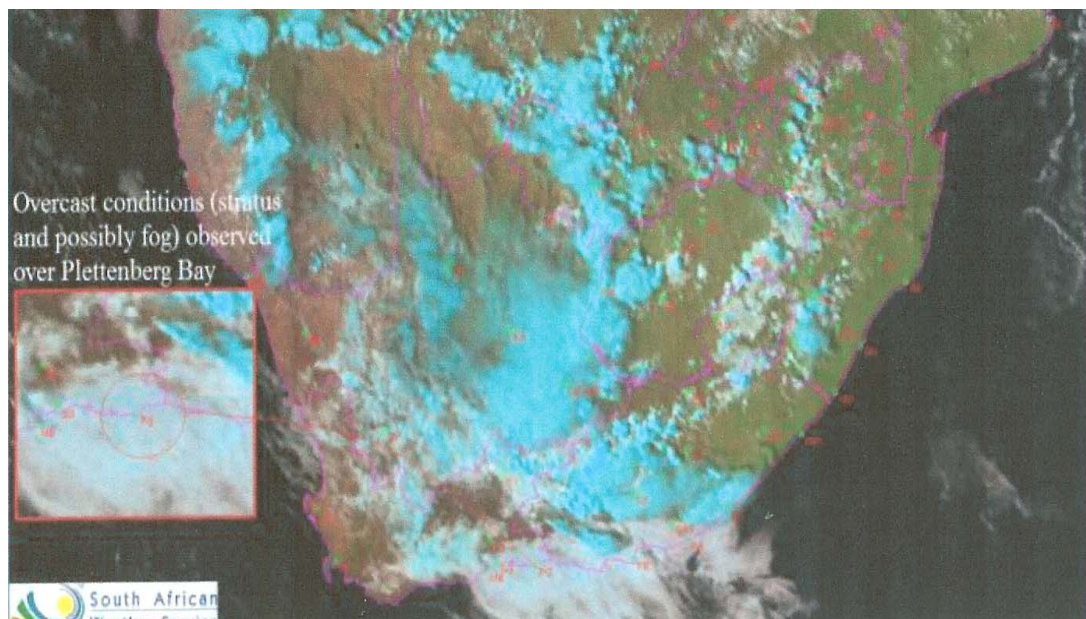
The satellite image (below) reflects overcast conditions along the south coast extending to the adjacent interior, low cloud demarcating the adjacent mountains also indicative of the presence of low stratiform clouds and possible thick fog with drizzle.

A satellite image of the country that was taken at 1430Z on 8 February 2011.

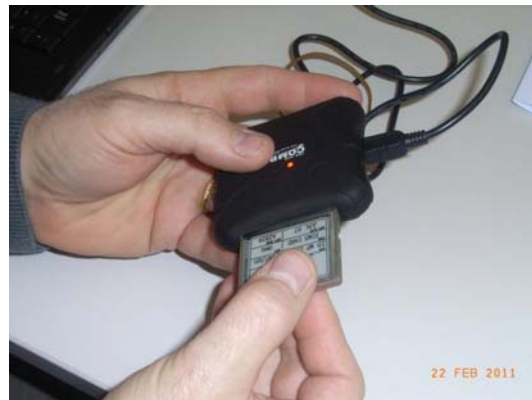
Figure 3. Card Reader

Conclusion

“The EIS memory card most likely sustained internal damage to such an extent that normal data download using the normal tooling was not possible. The reason for this damage was most likely the penetration of salt water into the card itself”.

The actual vendor/manufacturer of the memory card was contacted following the download attempt of the memory card referred to above. They indicated that the memory card was not designed nor manufactured as a waterproof unit and by being exposed to the sea water for several days, the flash chip inside most probably deteriorated/broke, with the result that the downloading/retrieval of data was not possible.

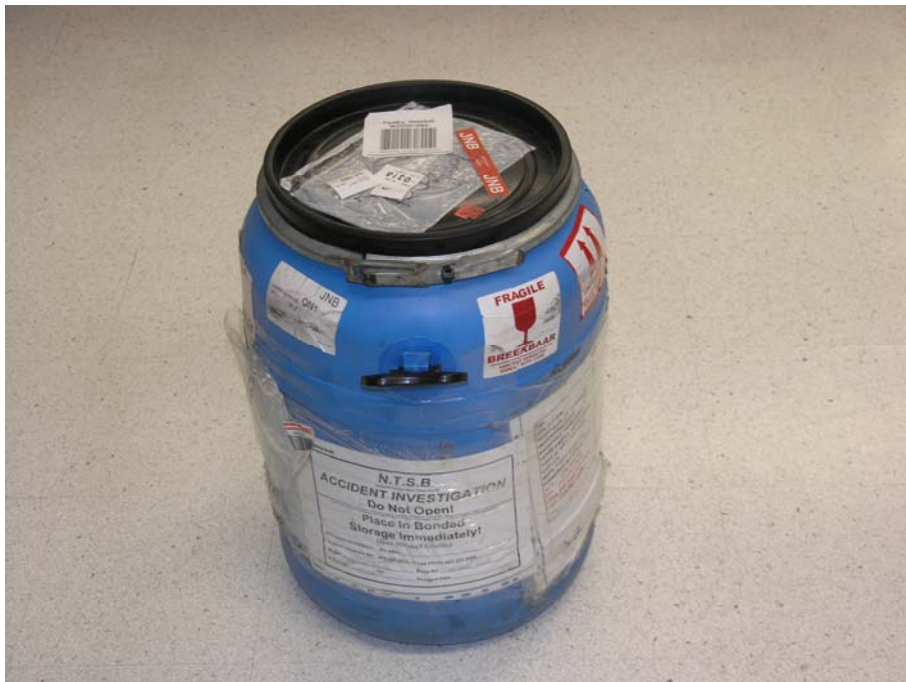
A view of the sealed container that was used for transporting the unit to the U.S.A.

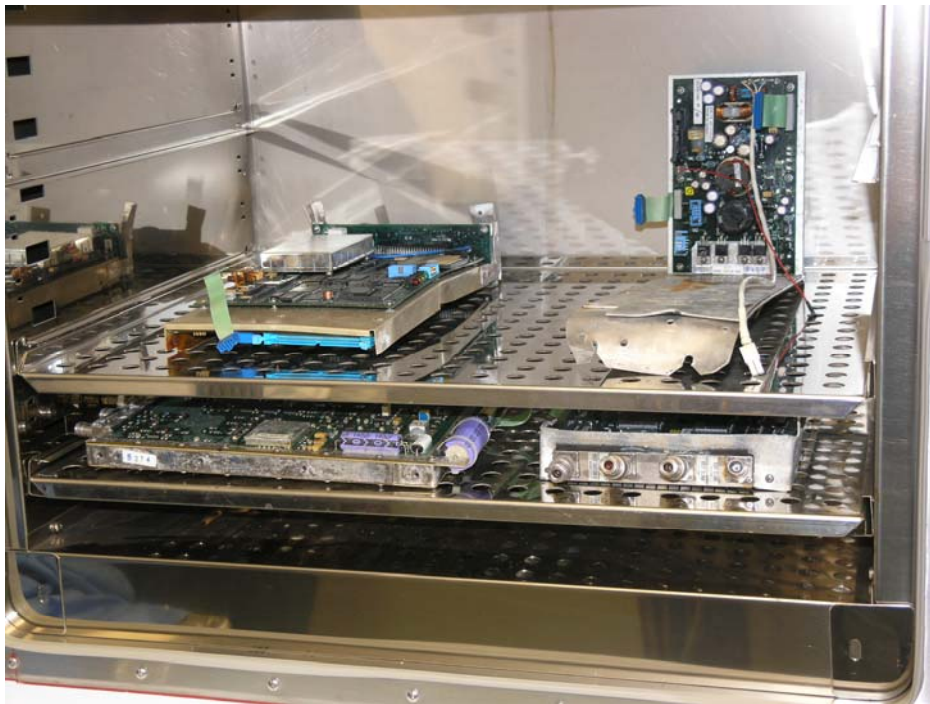
The dismantled unit being prepared for the drying-out phase at the Honeywell laboratory.

The EGPWS module installed on ZS-GAA was inoperative (INOP) at the time of the accident due to a failure of the internal Terrain Database. Honeywell has not determined any probable cause for the internal failures as the unit had been submerged in salt water and was mechanically damaged during the accident.”

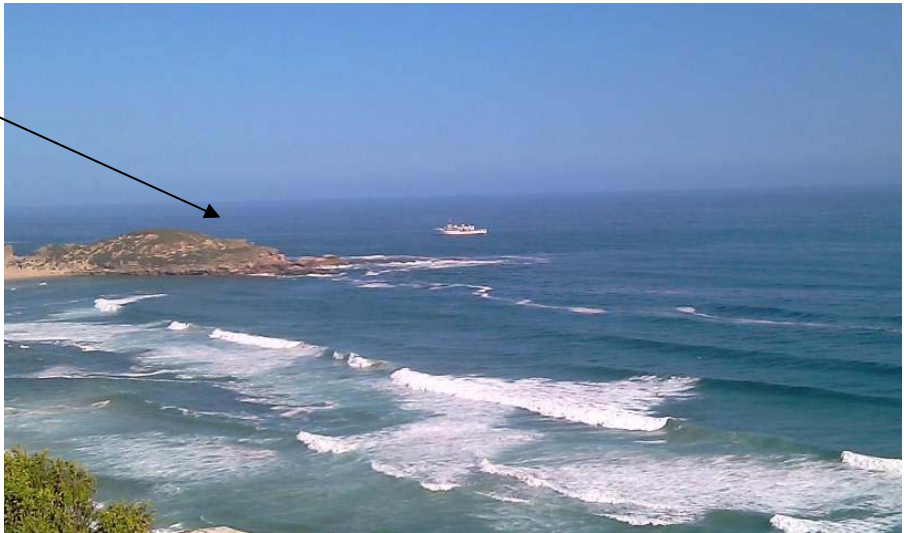
1.12.1 Due to the fact that the aircraft crashed into the sea, no official wreckage diagram could be drawn up, as it was essential to recover as much of the debris in the shortest possible timeframe. No underwater video or photos were taken of the wreckage. This decision was supported by the fact that the wreckage was at a substantial depth, which limited diving time and made the recovery of wreckage parts a priority. The last known heading that the aircraft was tracking before it disappeared from radar was approximately 006°M (341°T + variation of 25°).

Figure 1. Estimated impact location (viewed from land).

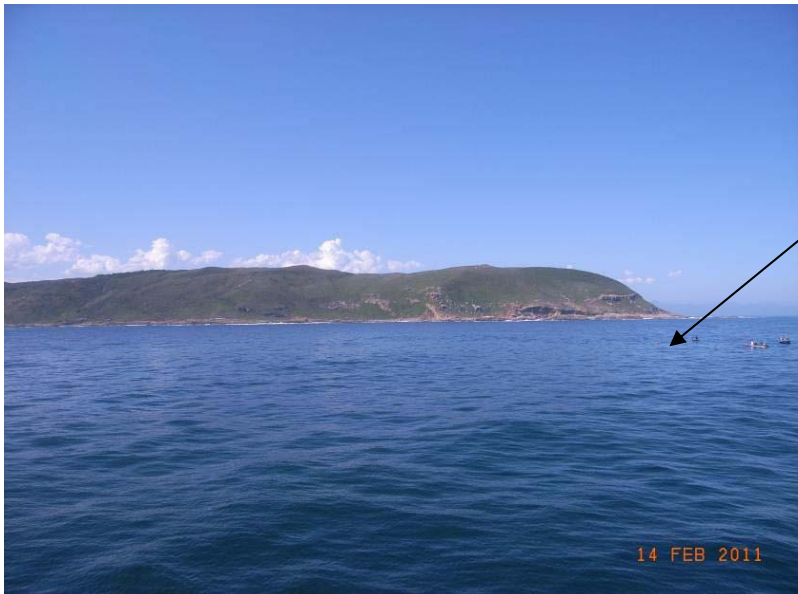
Estimated impact location

Figure 2. A view from the sea of the estimated impact location.

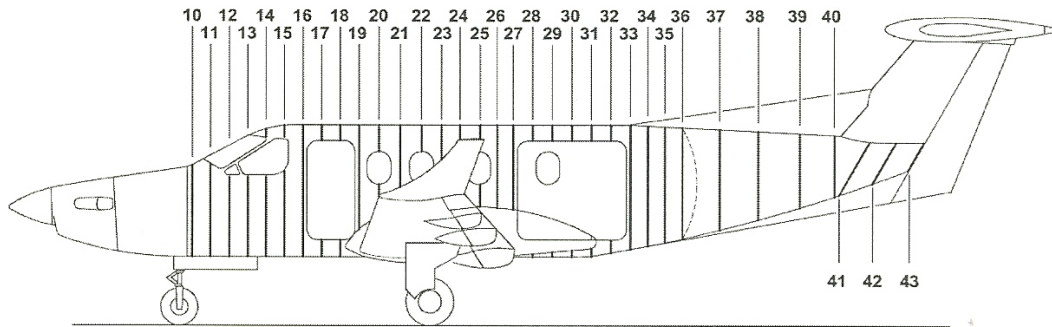
Several parts of the fuselage section were recovered, however, except for a few parts, the entire section from frame 10 (firewall) to approximately frame 27 (in front of the cargo door) is still missing (see figure 6 for reference to the frame numbers). This includes the right wing, from which only the weather radar dome/cover and the

Figure 6. Fuselage Structure Identification

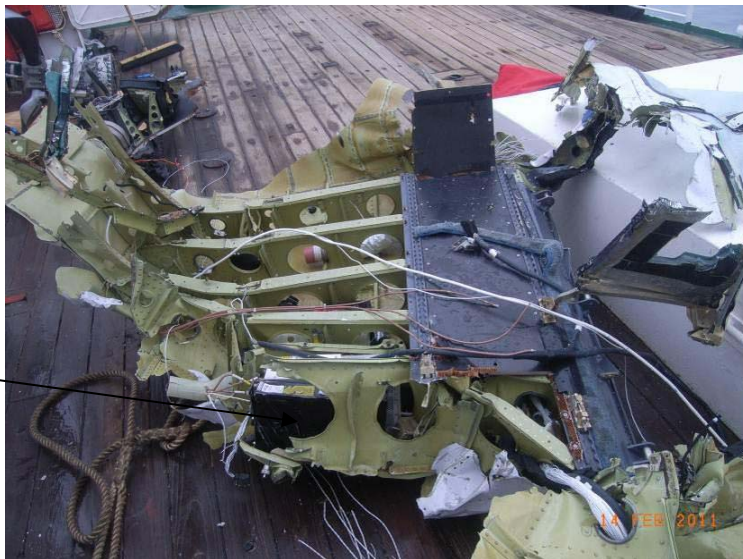
Figure 12. Bottom part of the cargo door, fuselage section.

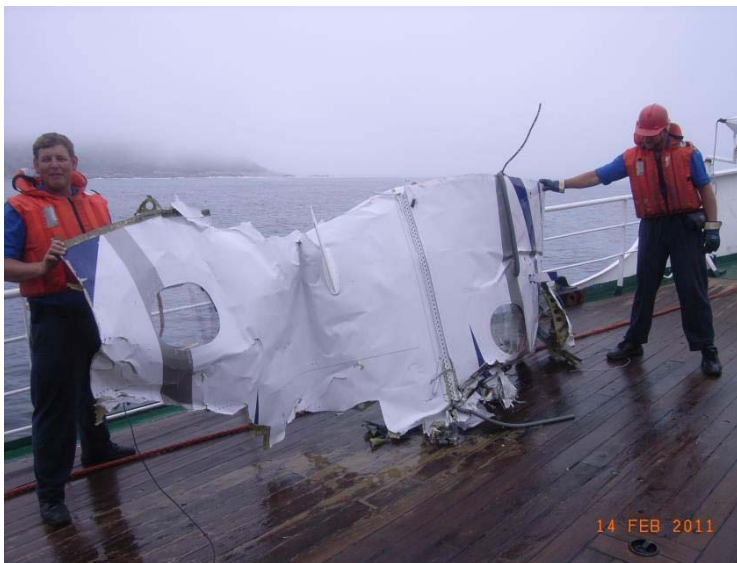
Figure 13. Top part of cargo area, fuselage section.

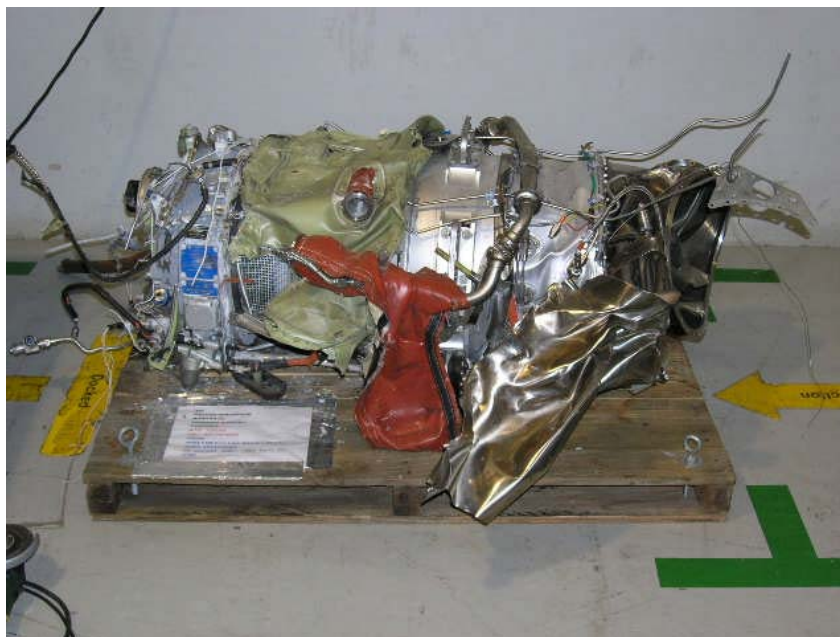
“A brief summary of observations, engine displayed deformation to the compressor 1st stage blades and contact signatures to the compressor axial stages, compressor impeller and shroud, compressor turbine, 1st stage power turbine vane ring and shroud, 1st stage power turbine, 2nd stage power turbine vane ring shroud, 2nd stage power turbine, and torsional fracture of the reduction gearbox propeller shaft coupling webs characteristic of the engine producing power at impact, likely in the middle to high power range. There were no indications of any pre-impact mechanical anomalies or dysfunction to any of the components observed.”

Photo No. 1
General view of the engine (right-hand side).

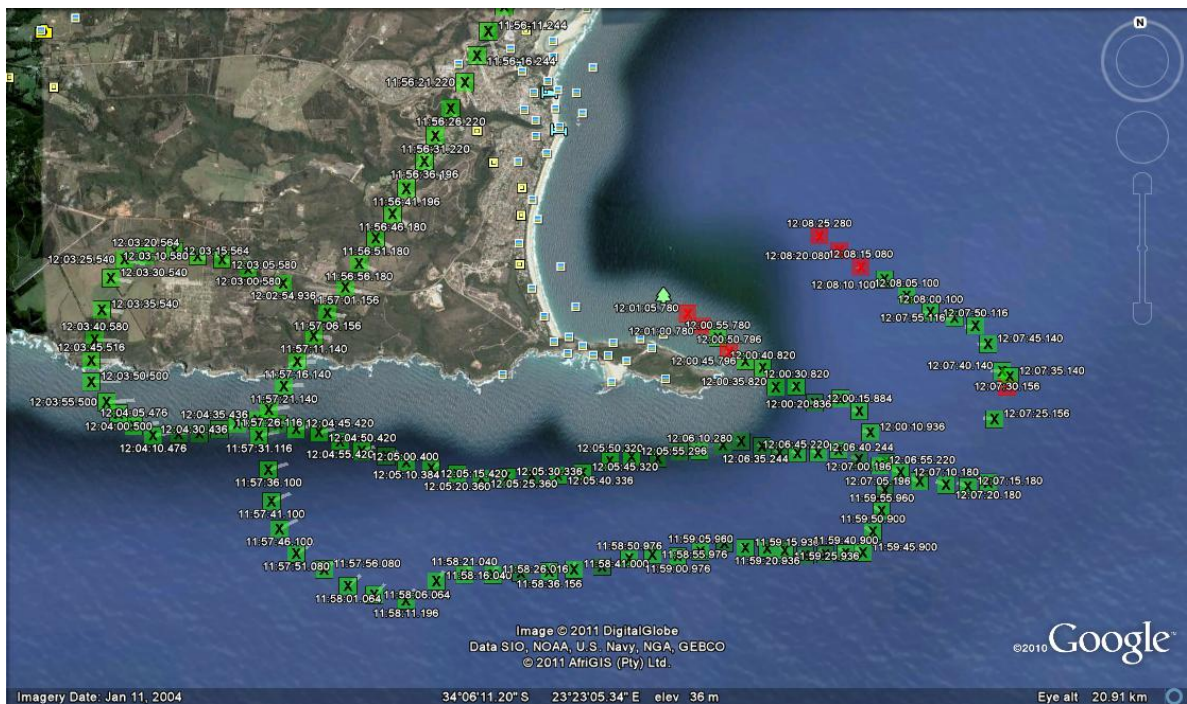
As part of the investigation, the Accident and Incident Investigation Division (AIID) obtained the radar trajectory that was flown by the crew of a Cessna Citation (ZS-PAJ). This aircraft had departed from Lanseria aerodrome (FALA) on a flight to FAPG. The aircraft landed at FAPG at approximately 1210Z approximately 2½ hours before the accident aircraft (ZS-GAA) was expected to land at FAPG. On the Google Earth map below it can be seen that the aircraft (ZS-PAJ) approached FAPG from the north-east, flew over the NDB beacon “PY” at the aerodrome and then turned out left, outbound over the sea and after some distance turned right inbound to intercept the beacon. On final approach the crew performed a missed approach as they encountered low cloud and rain, which reduced their forward visibility considerably and it was decided by the PIC to climb out and enter the pattern for a second landing attempt. On the second leg they extended their outbound leg over the sea and after some distance turned right to intercept the beacon followed by an uneventful landing on runway 30.

On both the inbound legs (approach phase) radar coverage with the aircraft was lost, which could be attributed to the aircraft being on the descent to land (relatively low) as well as terrain (mountainous area) interference.

The radar pattern reflects the trajectory that was flown by the aircraft ZS-PAJ that landed at FAPG at $\pm 1210Z$.

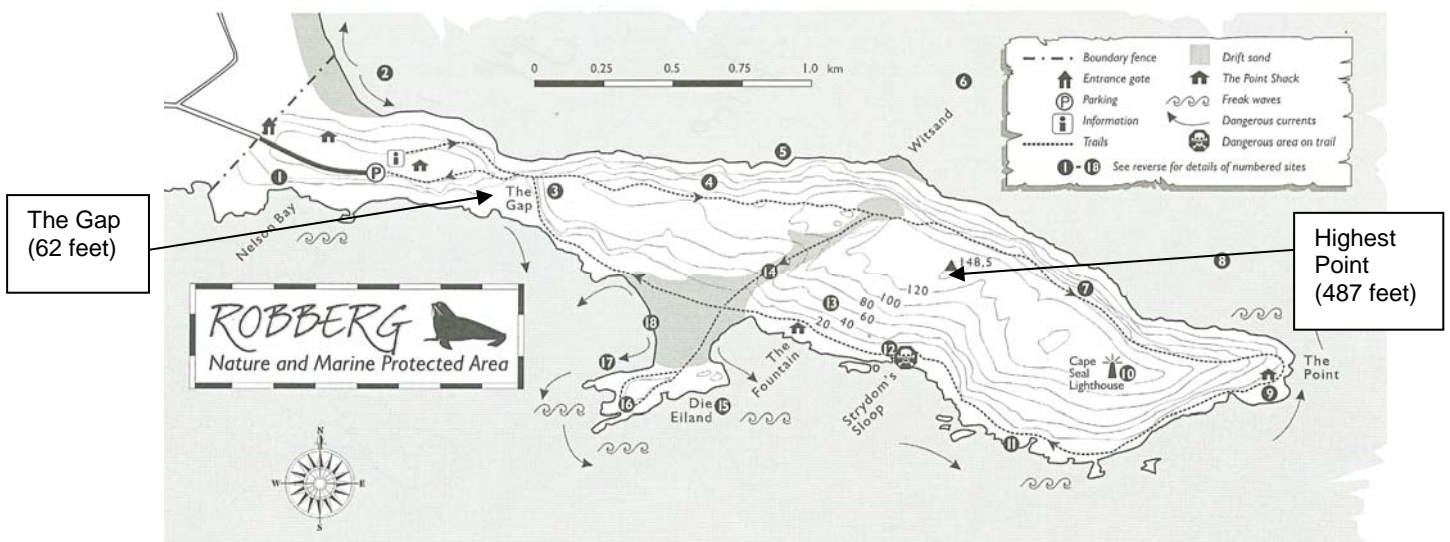
The loss of radar coverage around the Robberg point could be attributed to high ground/mountainous terrain, with the highest point on the Robberg Nature Reserve indicated as 487 feet (148.5 m) above mean sea level (AMSL). The height of the terrain in the area of “The Gap”, which was the lowest point in the reserve (apart from the sandy beach area point 18 on map below) is 62 feet (19 m) AMSL, according to information obtained from Cape Nature. Both locations are pointed out on the map of the Robberg Nature Reserve below.

A map layout of the Robberg Nature Reserve with the “Highest Point” and “The Gap” indicated.

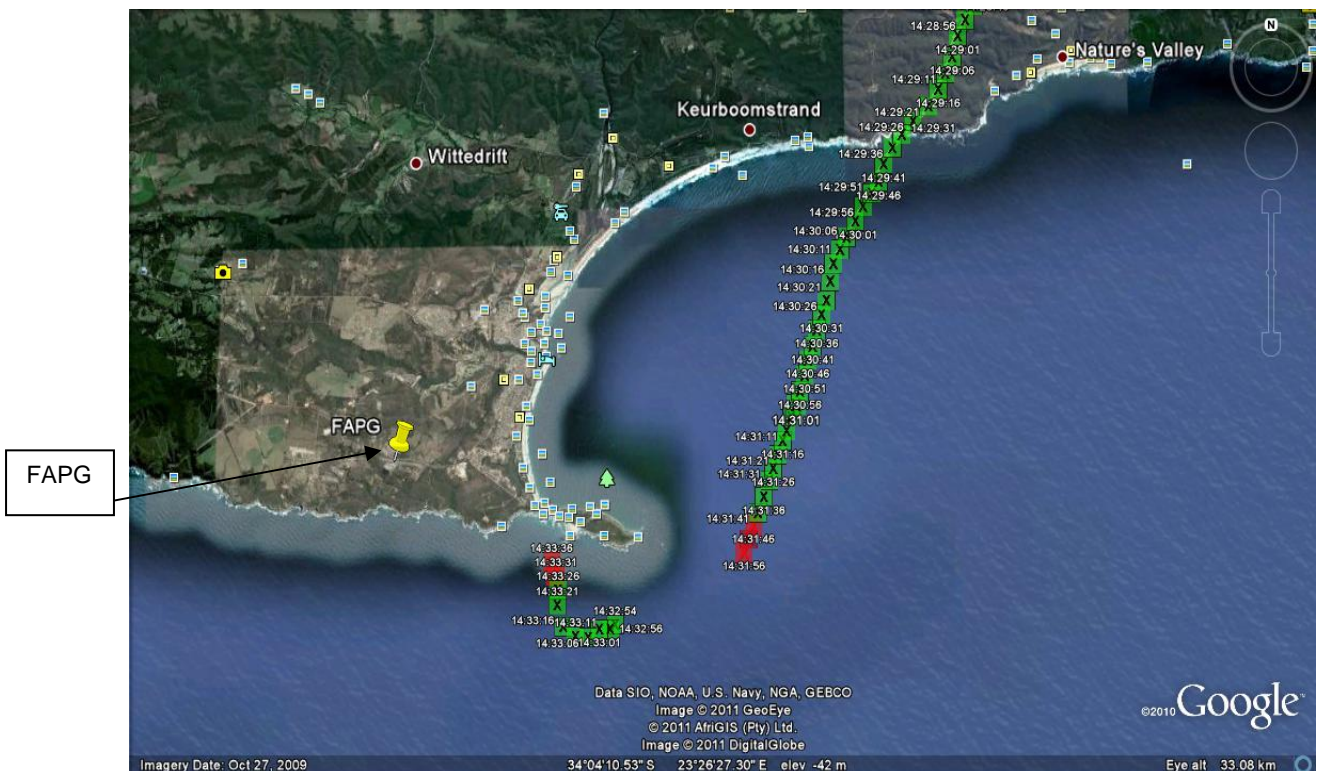
The last height reflected on the straight line approach's last 'green dot' was 1150 feet. Thereafter radar coverage with the aircraft was lost for a period of approximately 1 minute and was then re-established for a period of 1 minute before the aircraft disappeared from radar permanently.

The radar pattern reflects the trajectory that was flown by the aircraft ZS-GAA before disappearing off radar.

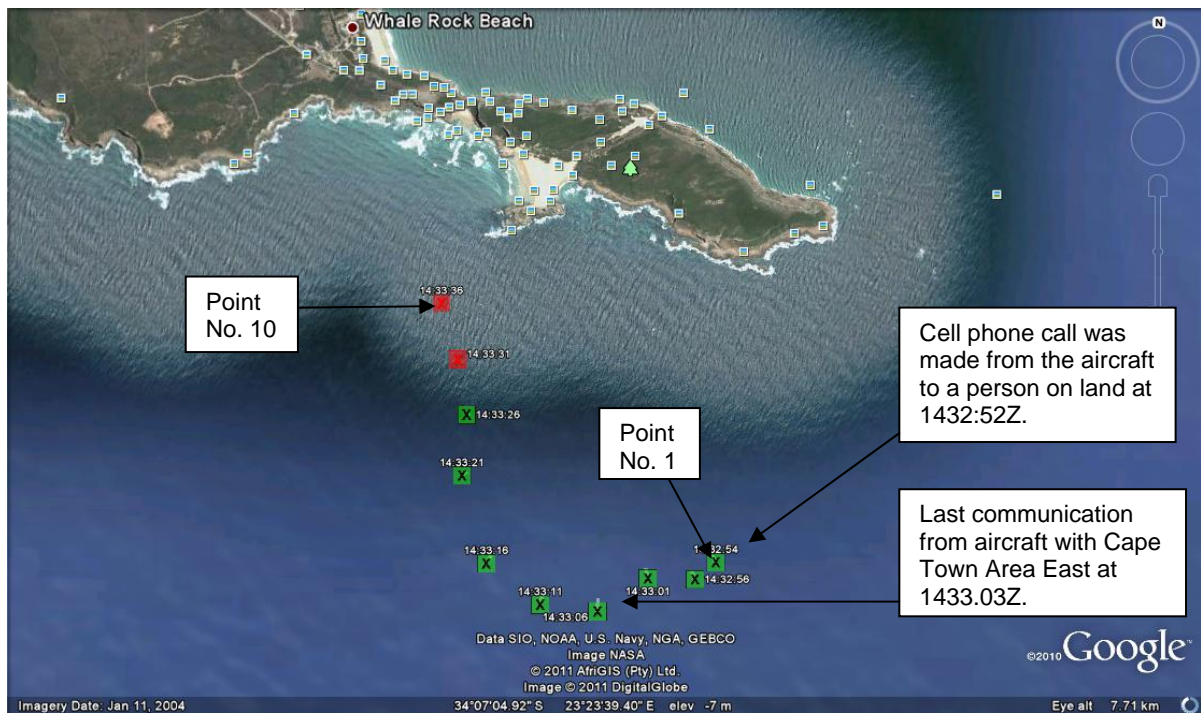
It is of interest to note that the aircraft was on the descent and during the right turn it pitched up from a height of 900 feet AMSL (position 1 out of 10) to a height of 1 375 feet in a period of 12 seconds. This accounts to a rate of climb (ROC) of 39.6 feet per second or 2 375 feet/min. During these few seconds the speed decayed from 168 to 151 knots. The pitch-up event was followed by an immediate pitch-down event with an associated rate of descent (ROD) of approximately 2 400 feet/min (this data was obtained by only utilizing data from the green track radar points). The aircraft continued to descend until it disappeared from radar.

The radar pattern reflects the trajectory of the aircraft (ZS-GAA) indicating the last 10 points/positions.
