“I wonder what will happen when I...”

Operate the Flap Interrupt Switch

By John Morris

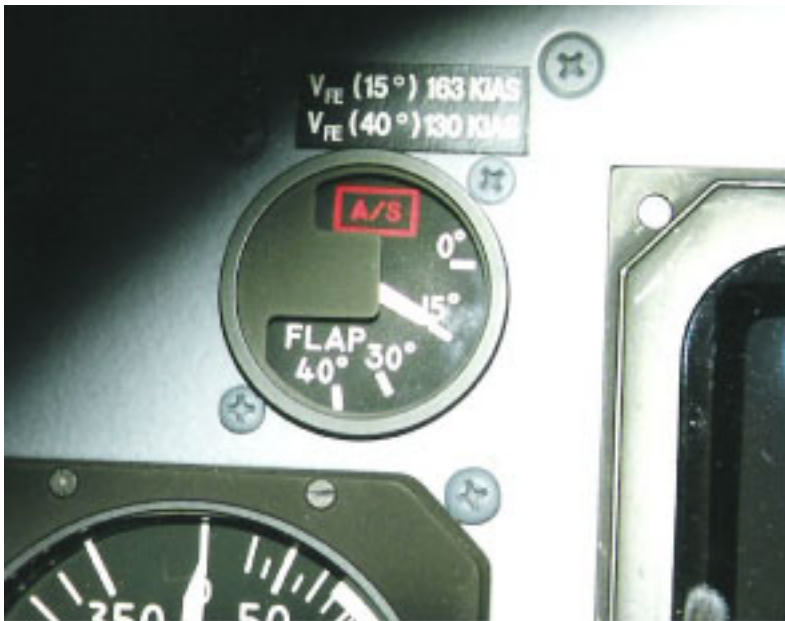
Overspeed indicator MSN 101-888

Lastly, the Flaps, Actuators and Flex cables are now inspected annually (used to be more frequent until improvements matured). Maintenance is checking for out of tolerance movement in the actuators and cables possibly caused by normal and overspeed stress, as well as panel deformity. Pilatus installed a Flap overspeed visual annunciator (in the Flap indicator MSN 101-888) and aural tone to alert us to this, NG aircraft have multiple indications on the PFD and a voice callout.
