## The Propeller Governors and the PC12

By John Morris

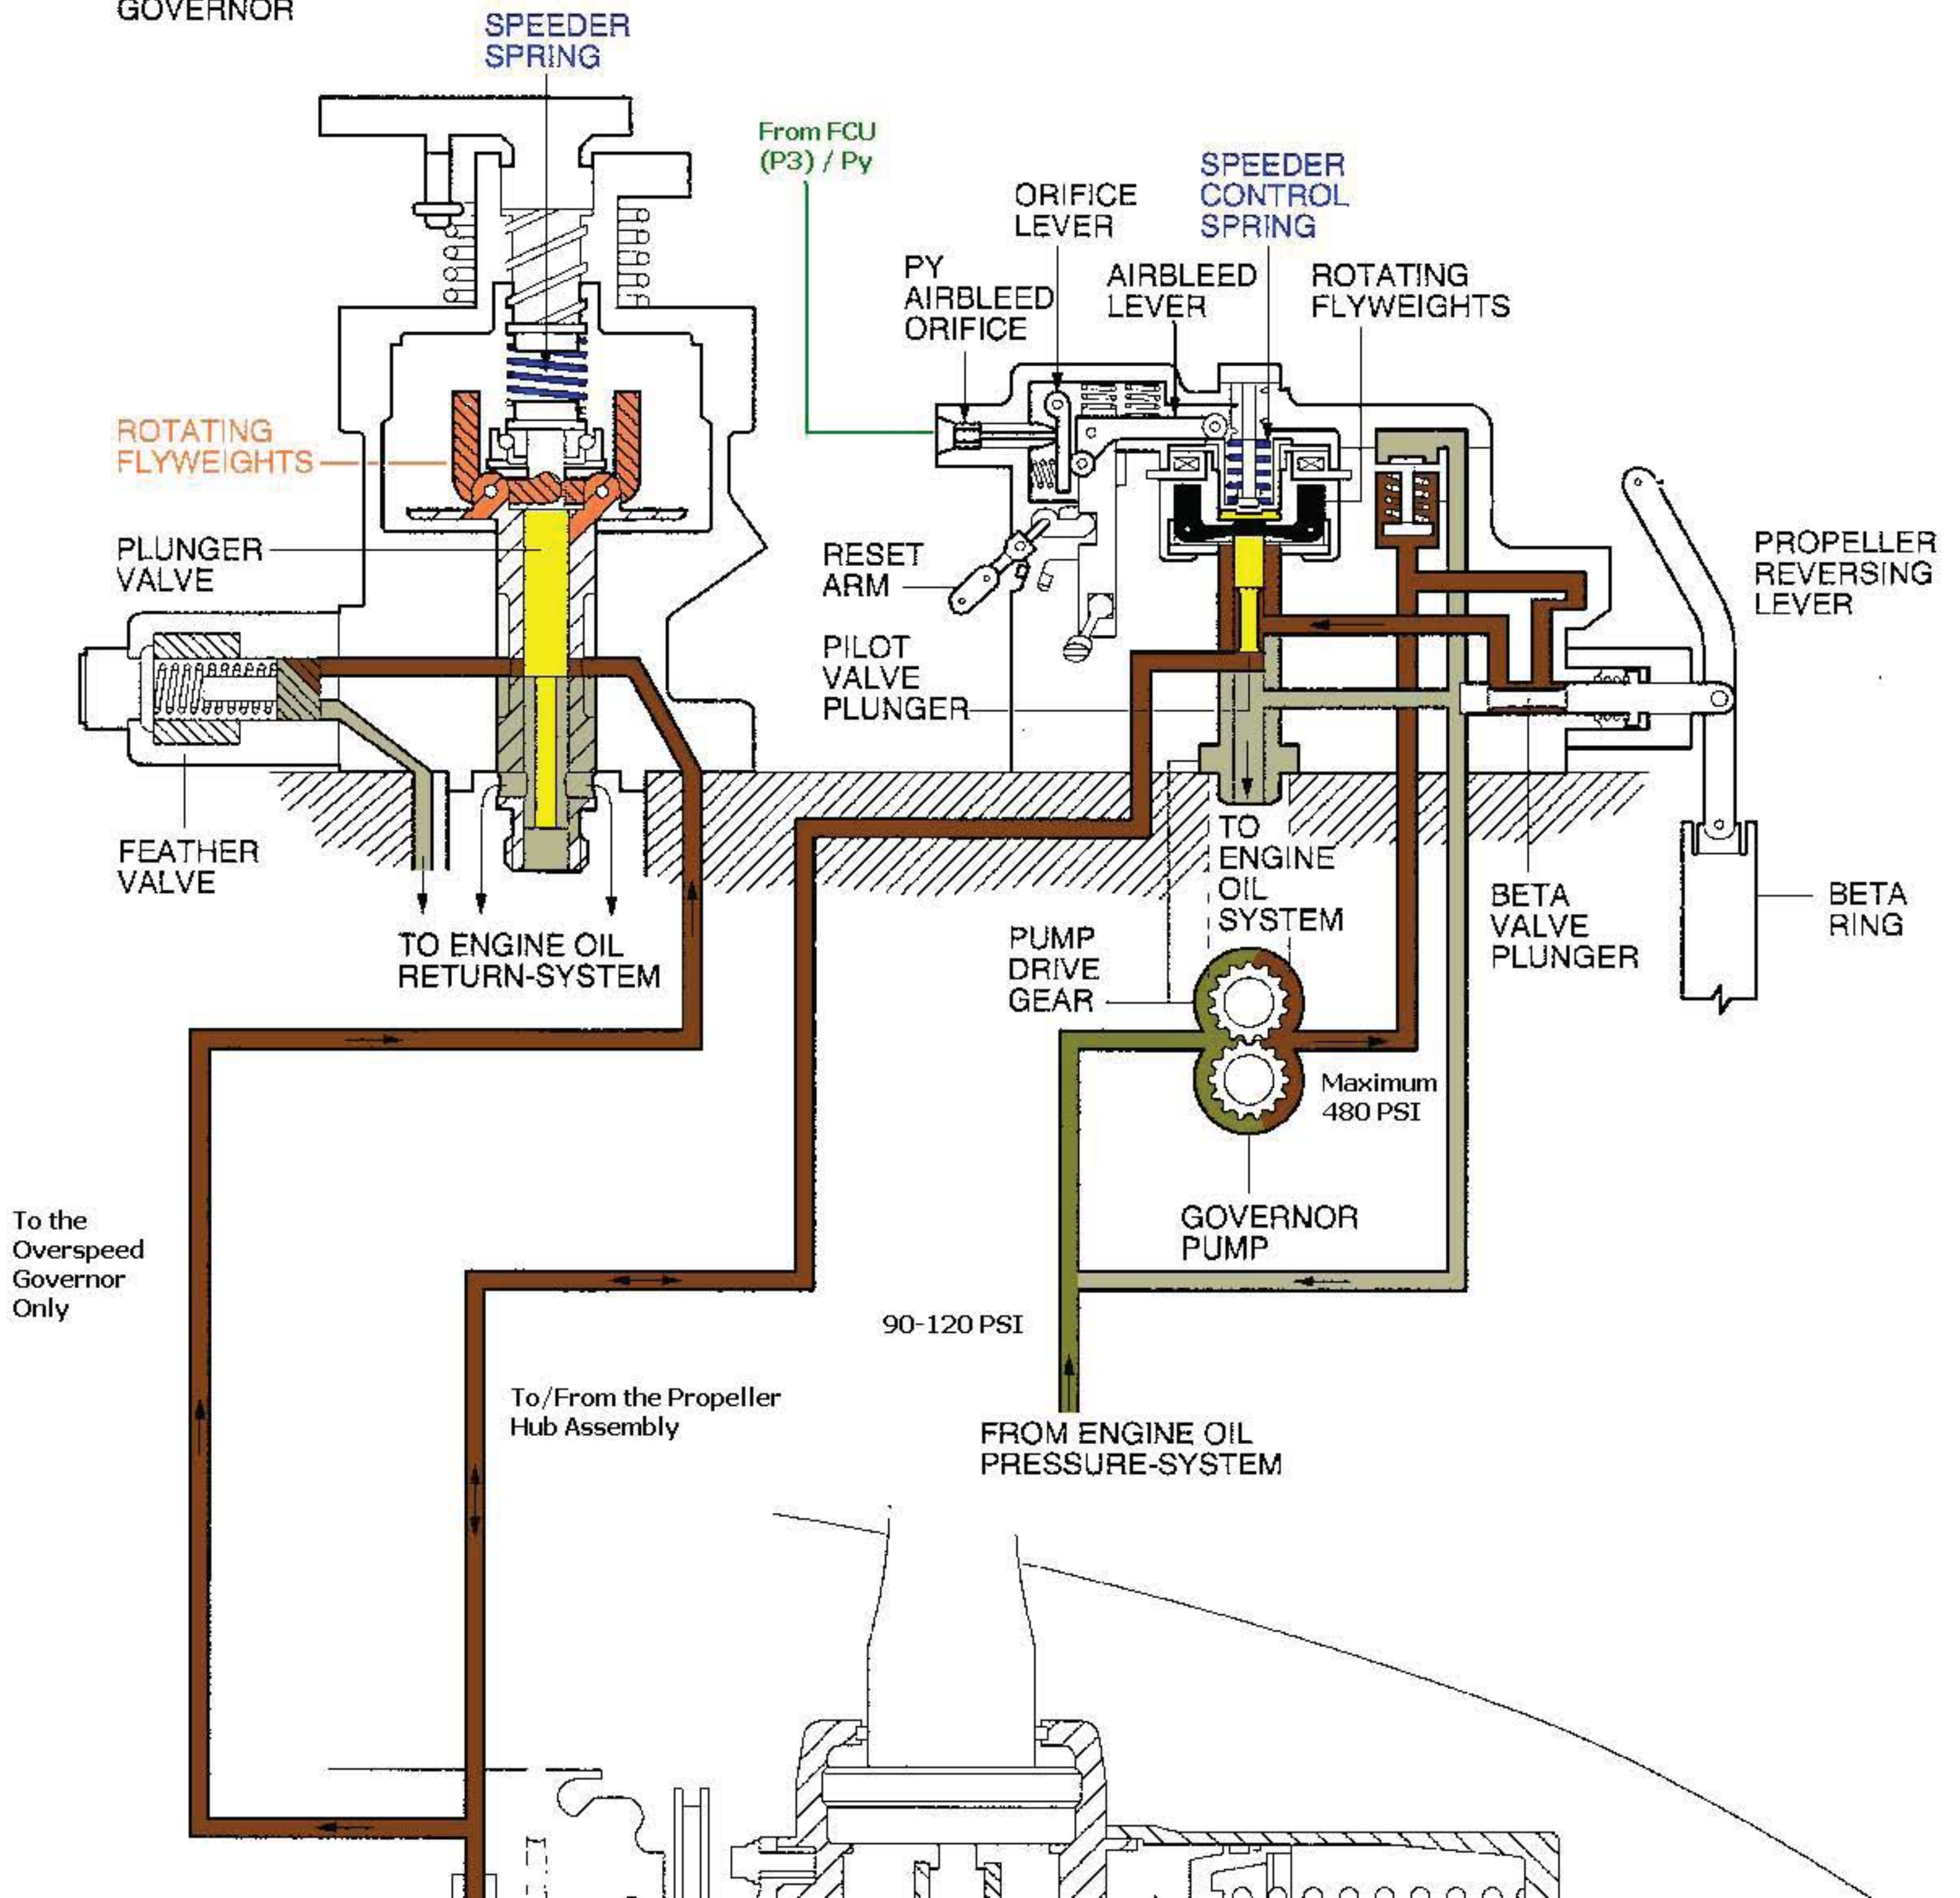
PROPELLER  
OVERSPEED  
GOVERNOR

PROPELLER  
GOVERNOR

As stated from the Pilot's Operating Handbook (POH), Section 7, Airplane and Systems (condensed): The propeller is powered by the engine through the reduction gearbox. Propeller pitch is adjusted by engine oil pressure regulated through the Propeller Governor/Constant Speed Unit (CSU). Oil pressure from the engine oil system is boosted to a higher pressure by a pump in the CSU.

Should the CSU governing system fail, the overspeed governor will operate to limit the propeller speed (Np) to 106% (1802 rpm).

Why high airspeed as the probable culprit? The CSU and Overspeed governor flyweights lost the ability to lift their respective plunger valves [shaft failure], but sufficient oil pressure from the CSU pump (propeller airspeed driven by the RGB) remained to keep the propeller at a high pitch. Also, the Nf section (fuel) of the CSU would be a non-function since reducing power had most likely already occurred. If you review the Propeller-Overspeed Emergency checklist you will see that when all else fails-REDUCE AIRSPEED. Or, as the case was with the U-28A, the engine had to be shutdown, probably due to excess vibration from the propeller overspeed (also in the checklist).
